Subj: Trip Report for LORSTA Kargabarun 4-19 JAN 82

1. Purpose. The purpose of this visit was to evaluate project work and to perform the engineering portion of the ACTEUR inspection program.

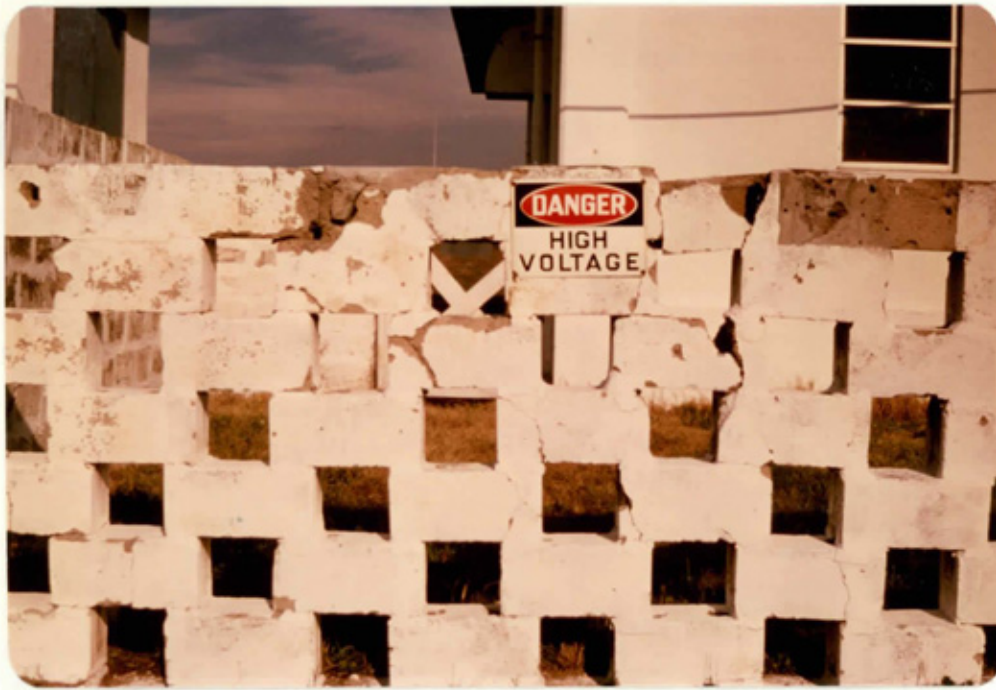
j. The fence around the tower base insulator is falling apart. The wall is currently two solid cinderblock walls with soil in between. The soil expands and contracts and causes early failure of the wall.

1. Cinder block fence, showing typical cracking

e New tower base fence should be a solid concrete block of double thickness. This should eliminate the current problem and still maintain an increased security for the tower base insulator.

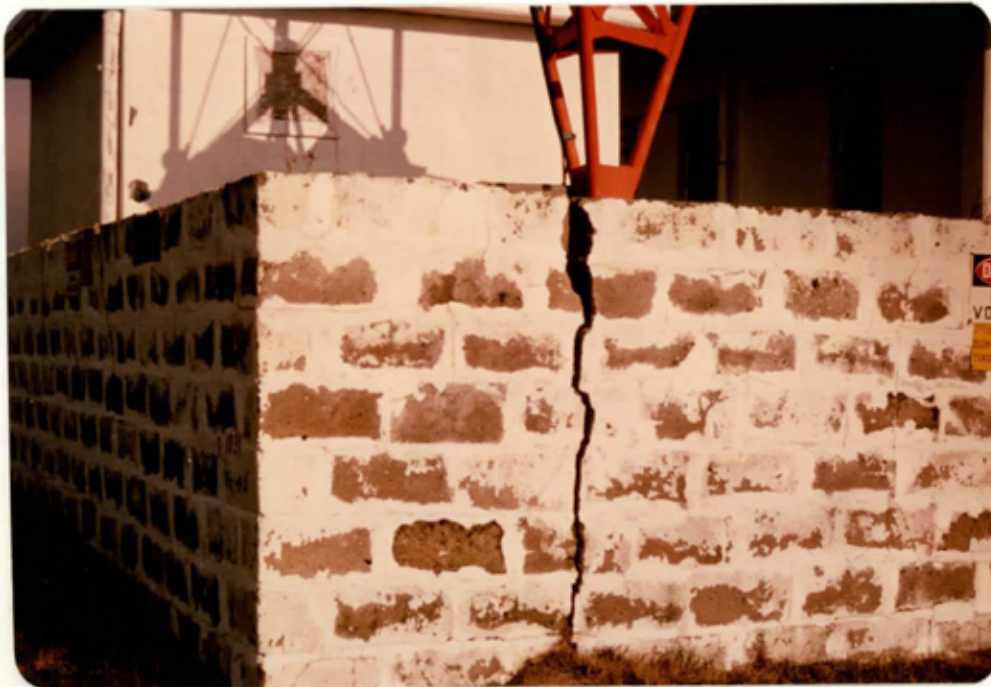
2. Tower base fence showing crack caused by soil expansion

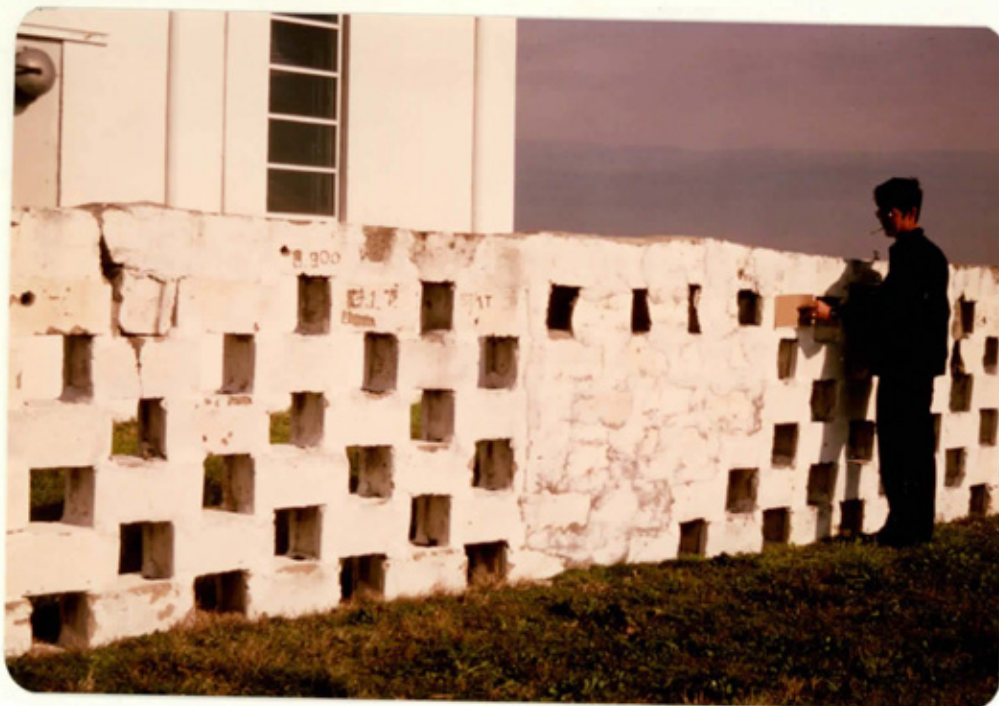
3. Station has been doing a good job repairing fence cracks

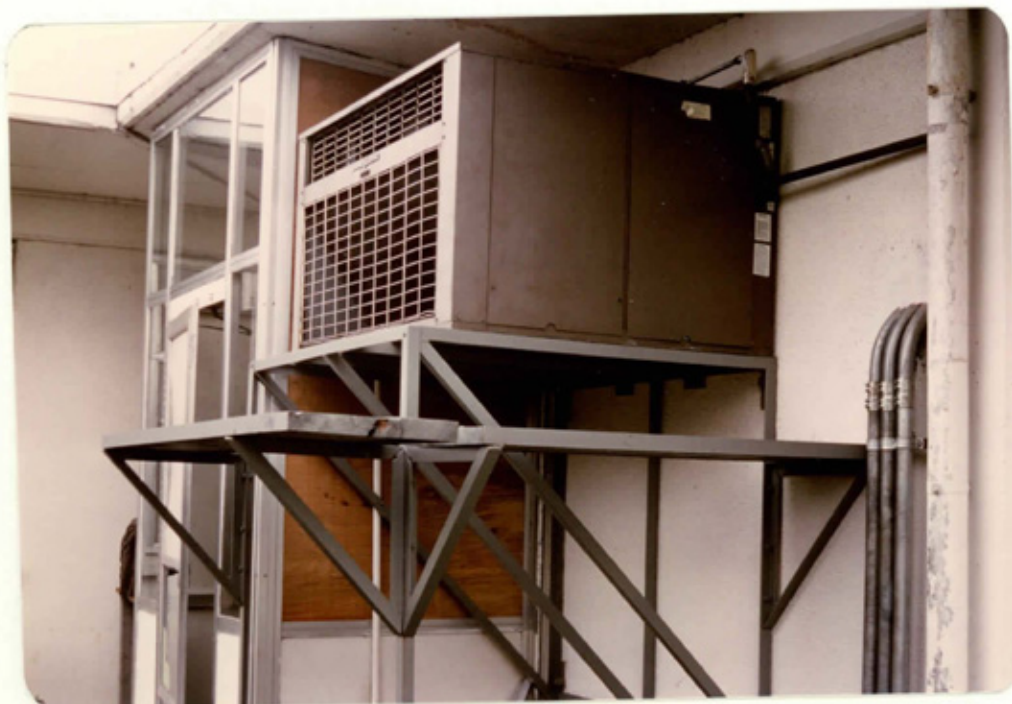
4. Station has built walkways around heat pumps/units

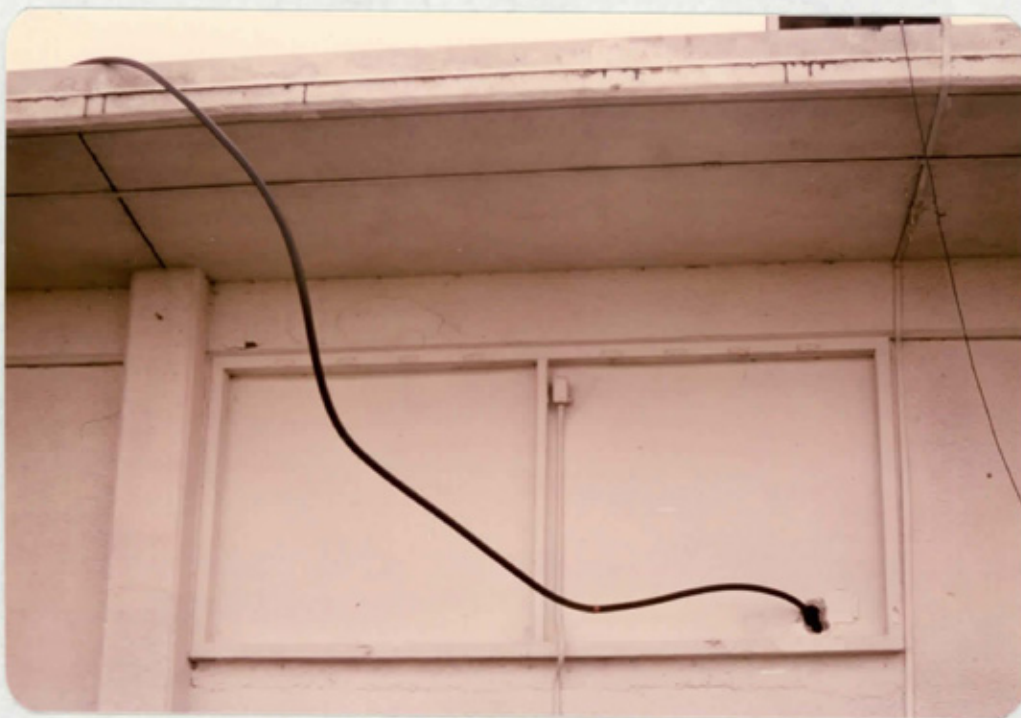
5. Cable to microwave link antenna which should be secured

The microwave link antenna cable should be secured to prevent damage to the antenna and the building walls. The cable should also be properly run with non-chafing material and insulating material, through the building exterior wall.
