TRIP REPORT

CIVIL ENGINEERING DIVISION VISIT

Station visited: LORSTA KARGABURUN

Dates of visit: 10 OCT 84 to 25 OCT 84

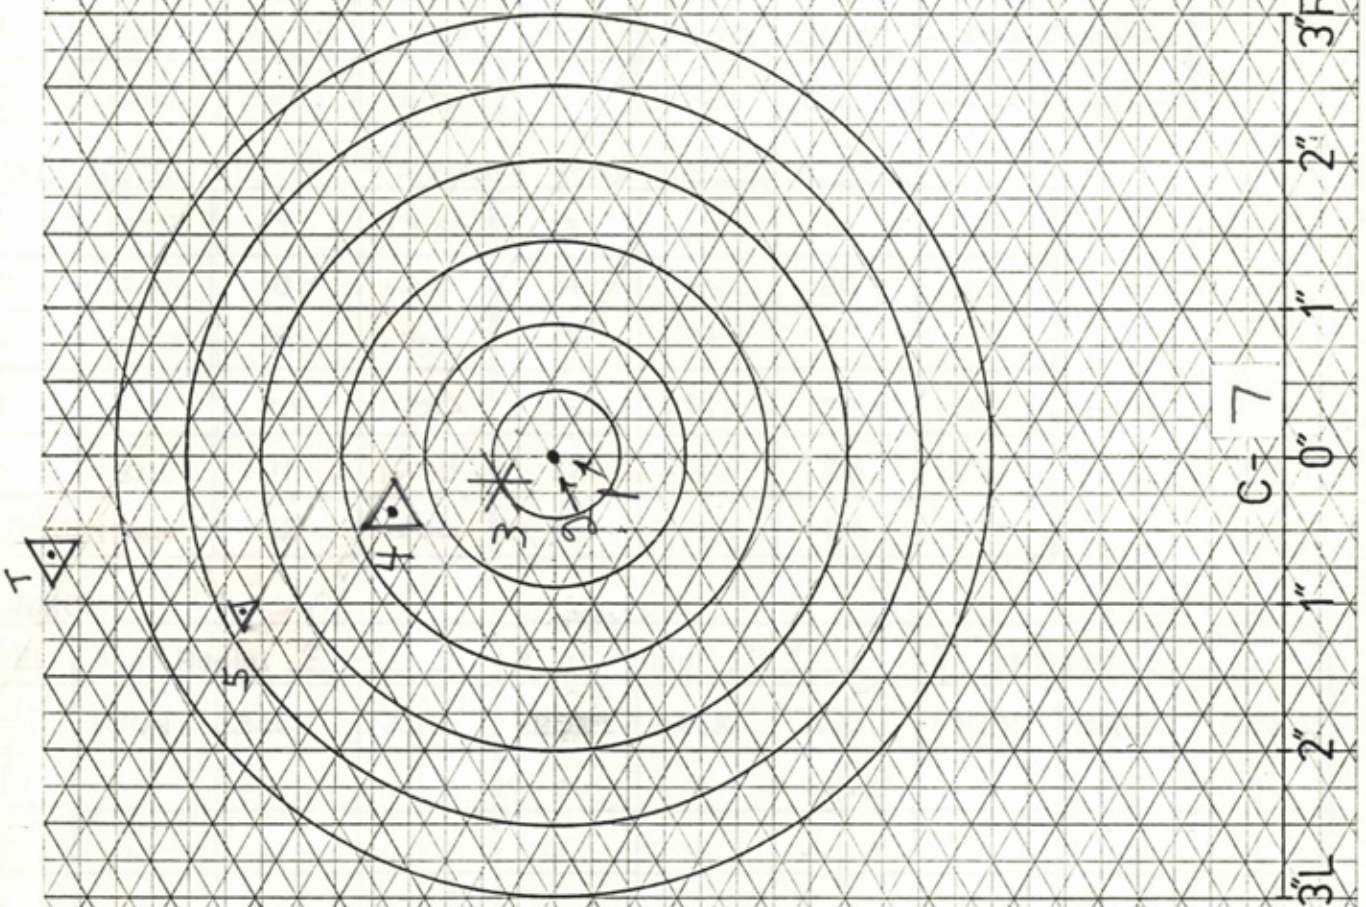
Plot 1

MAXIMUM DEFLECTION
 BETWEEN GUY LEVELS =
 1 1/2"

- 2.1 Re-aligned and retensioned tower as suggested in 1984 Tower Inspection Report. The initial tower plot and tension readings showed the tower to be out of alignment tolerance and several tension values were high. The tower was adjusted three times; first, minor adjustments of the radials; second, major adjustment of the radial and structural guys, and lastly, minor adjustment of the structural and TLE guys, which the results are documented in plot four. The results of the first and second adjustments are shown in plots two and three respectively. The structural tensions were left at the mid to upper portion of the allowable range but about half the TLE guys were left a bit above the allowable range. Because of the balanced structural tensions and excellent alignment the TLE guys were left at their high values since they too were reasonably balanced.

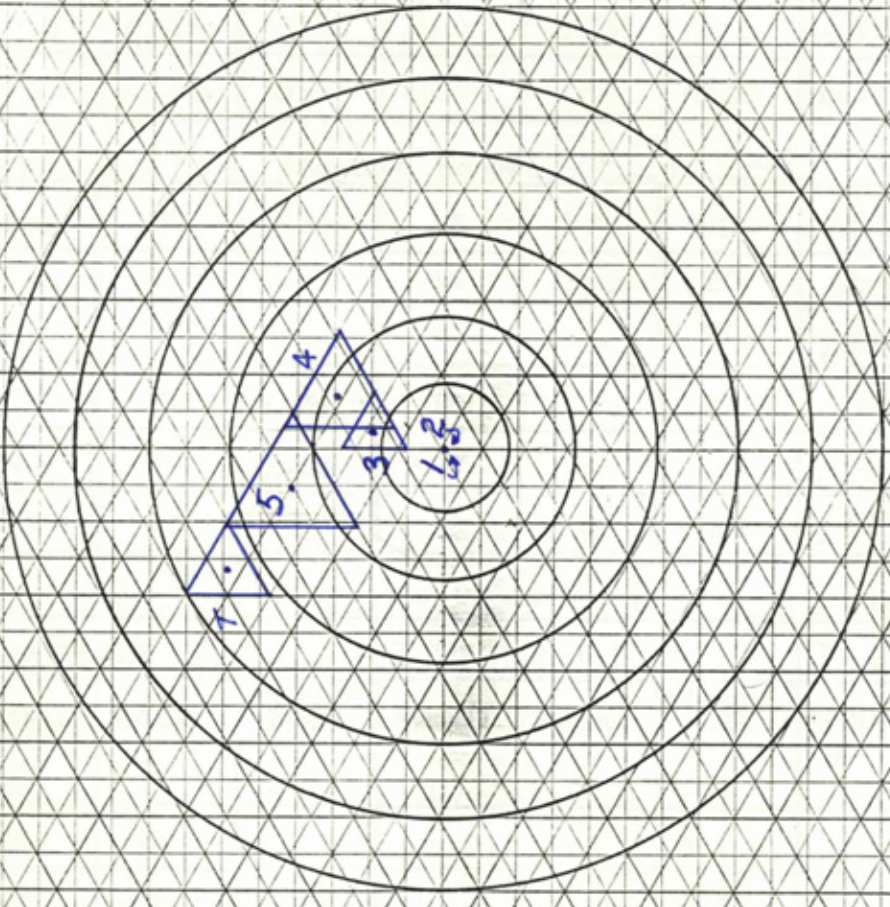
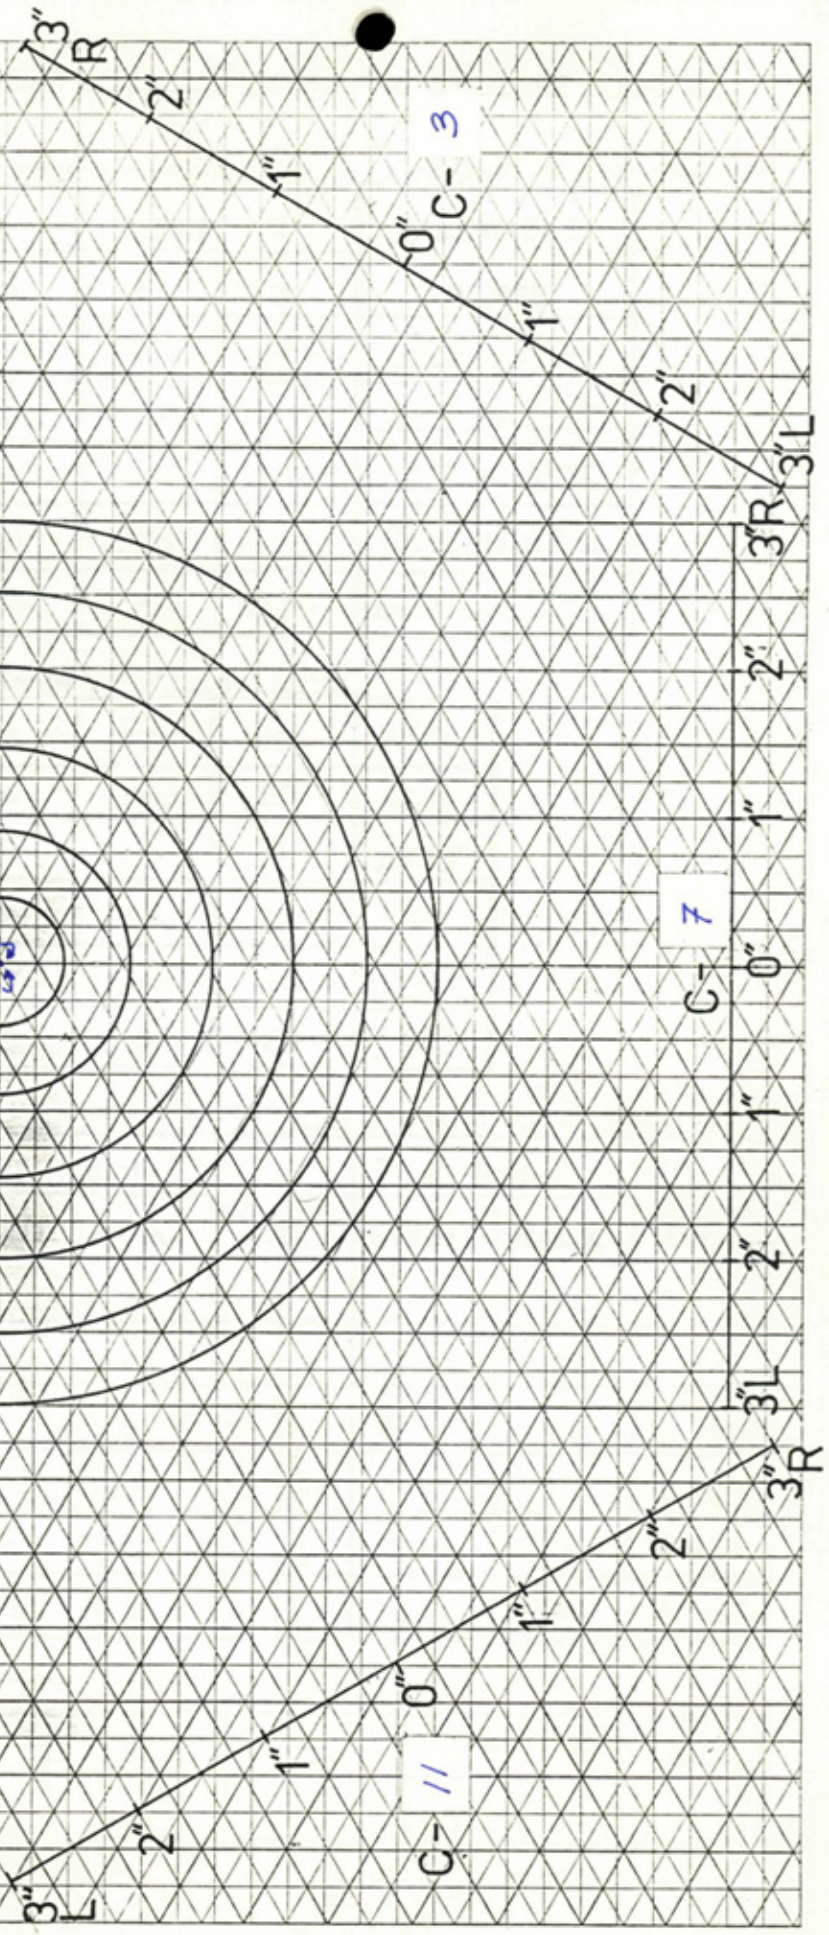
Plot 2

LORSTA: KARGABURUN
 DATE: 15 OCT 84
 WIND FM C-16 AT 8 KNTS
 MAXIMUM DEFLECTION
 BETWEEN GUY LEVELS =
1 1/2"

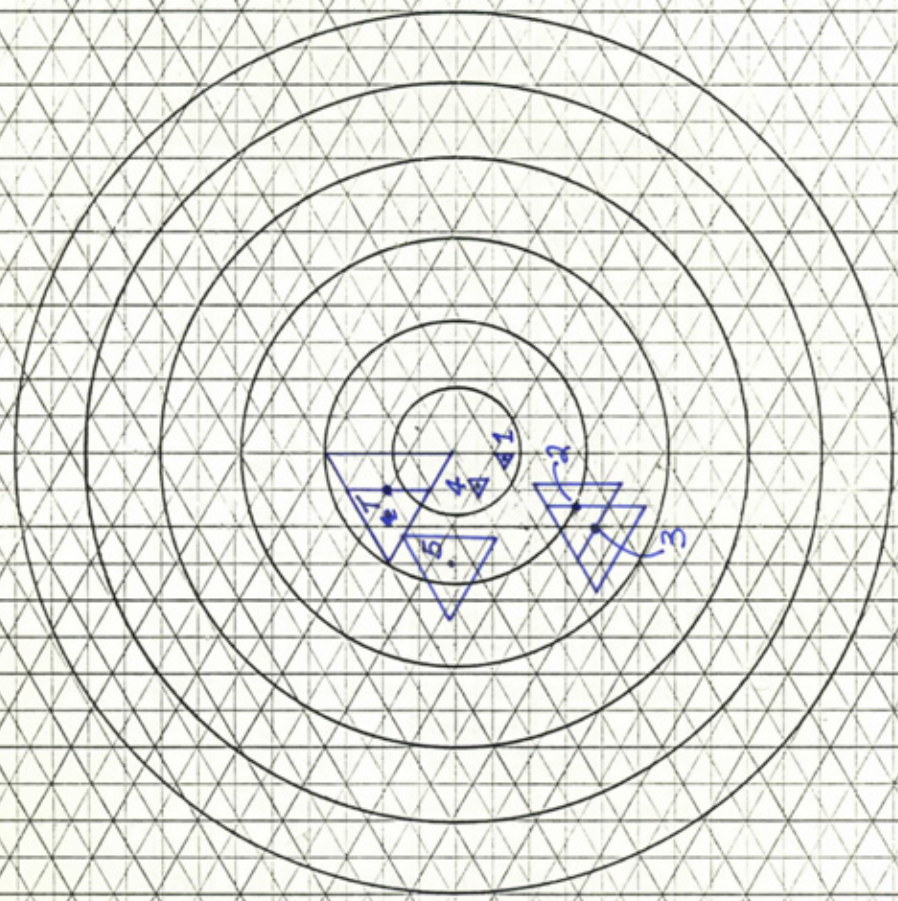
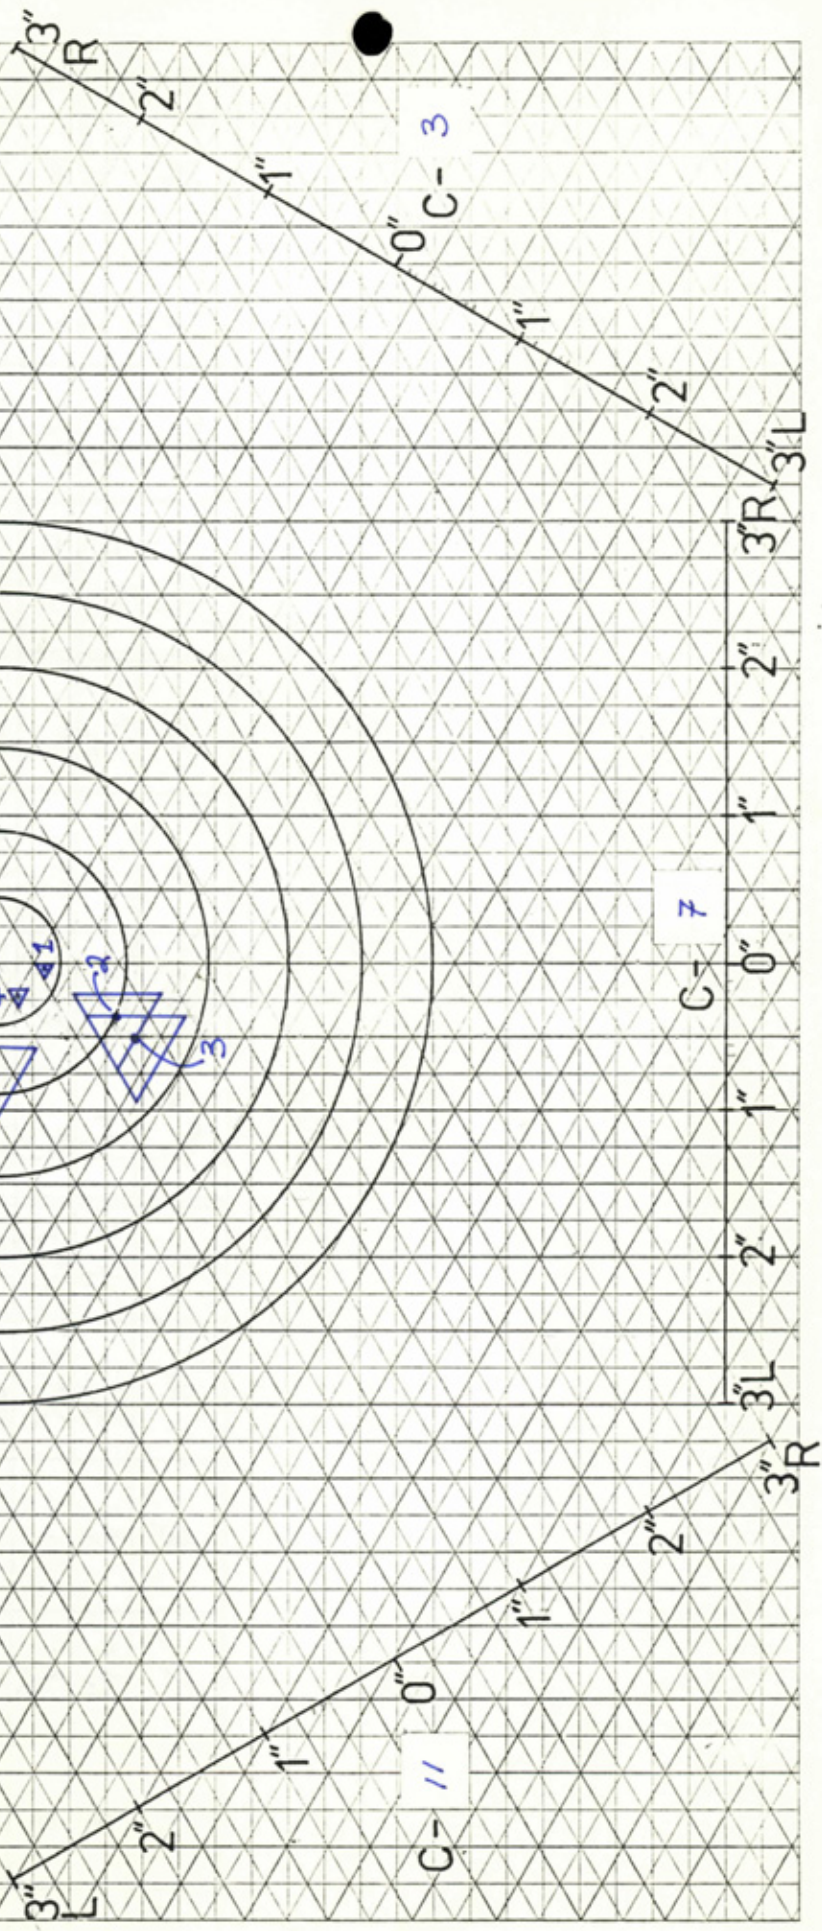
Plot 3

LORSTA: KARGABURUN
DATE: 16 OCT 84
WIND FM C- AT 0 KNTS
MAXIMUM DEFLECTION
BETWEEN GUY LEVELS =
1 1/2"

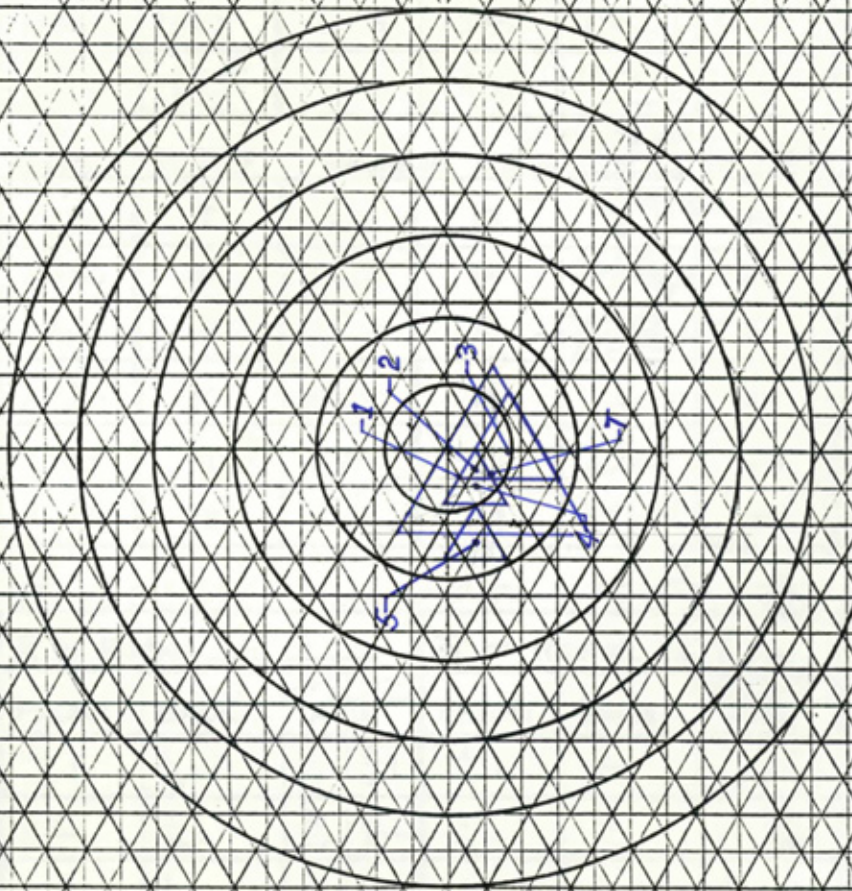
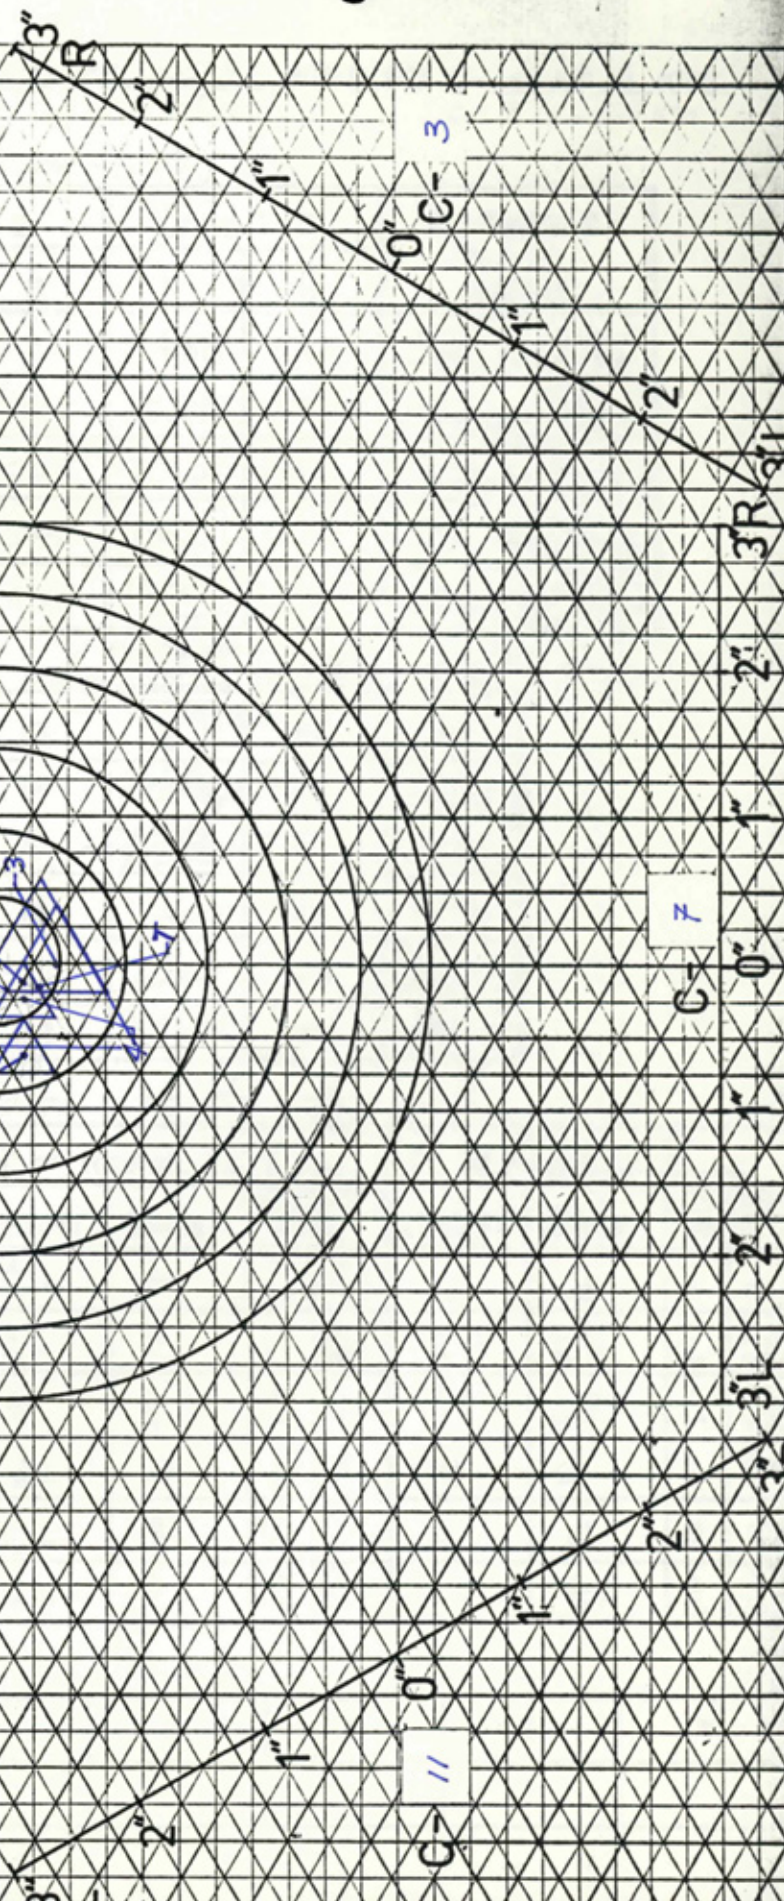
Plot 4

MAXIMUM DEFLECTION
BETWEEN GUY LEVELS =
1 1/2"
