United States
Coast Guard

Subject: LORSTA KARGABURUN TRIP REPORT

Date: 18 December 1992

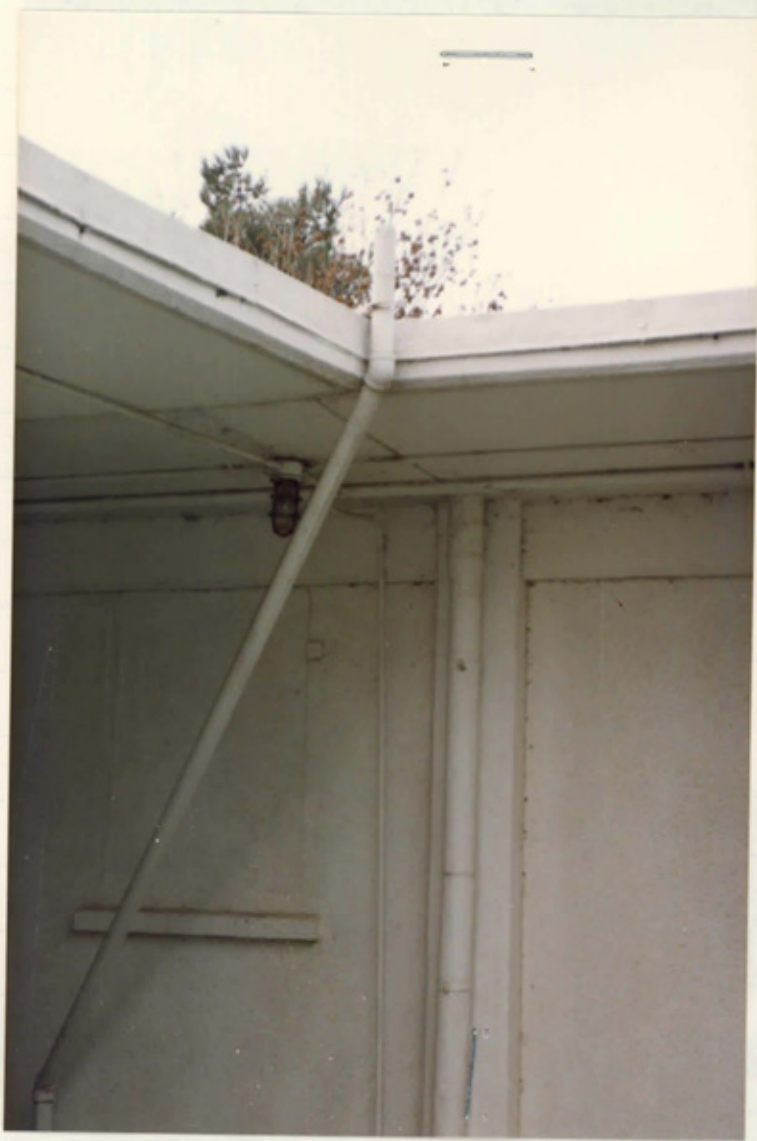
Photo #1
Sewage Vent Pipe - Barracks Bldg.

4. During the visit, there was a foul smell coming from the men's head when a strong wind picked up. MKC Perron and CWO Peterson showed me that there wasn't any "p" traps in the drainage lines leading from the sinks and toilets to the sewage tank. It looked like the wind was forcing air coming down the vent pipe bringing the sewage smell back up the drainage lines into the head (Photo 1). "P" trap would solve this problem. Because the existing pipes are already embedded in the concrete foundation, installing "P" traps is not feasible. We concluded that placing a wind vane on top of the vent would prevent air from traveling down the vent pipe and eliminate the odor. CWO Peterson and Colin McGuire are working on finding the source of supply for this solution.

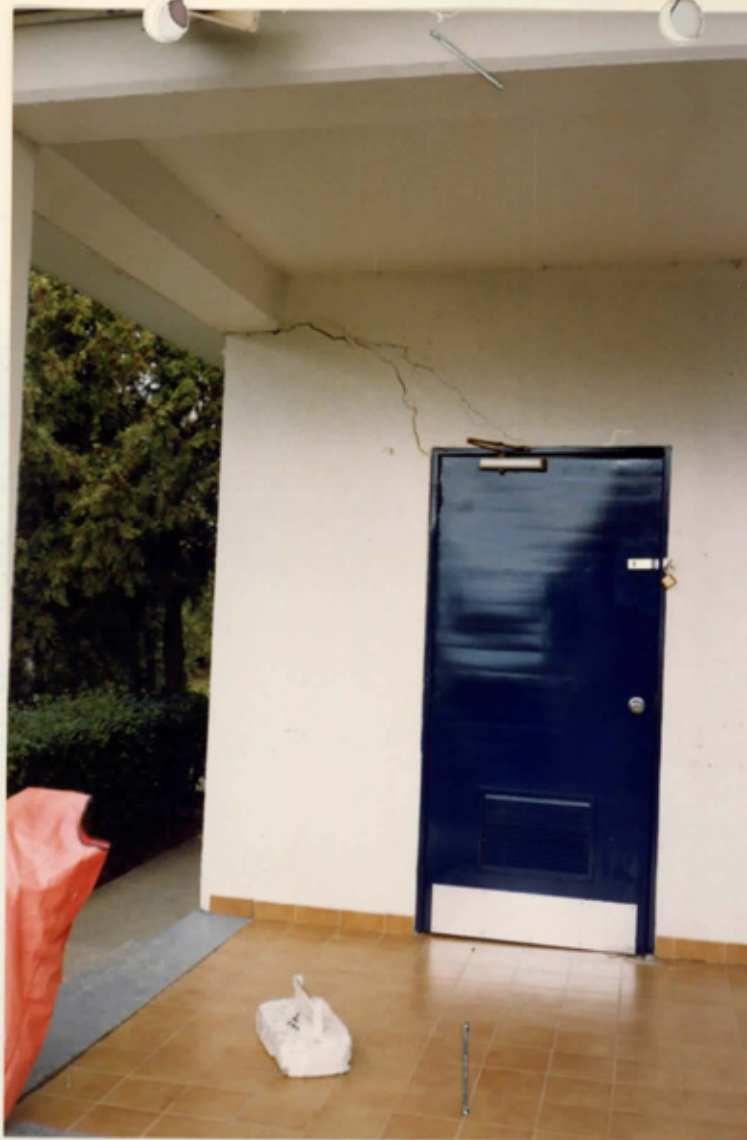
Photo #2
Exterior Corner
Laundry Room

6. There were severe cracks in the laundry wall as shown in photos 2 through 5. These cracks are not in the structural members of the building and can easily be patched by the unit. I got a look at how the Turkish build their buildings. Photo 6 shows an example of the typical construction. There are no structural ties between the vertical strength members and the side wall (side membrane) made of brick. This type of construction would not meet California Seismic requirements. Similar cracks were also evident in the galley storage area.

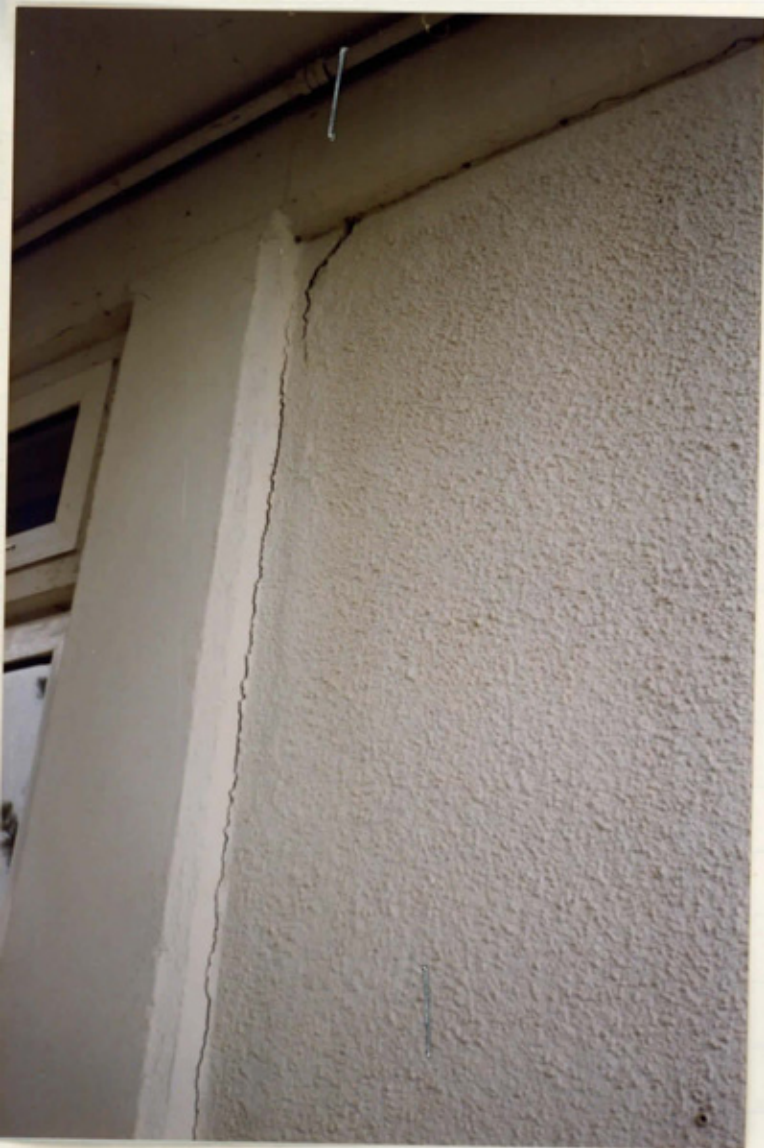
Photo #4
Laundry Room Exterior
Side Wall Crack

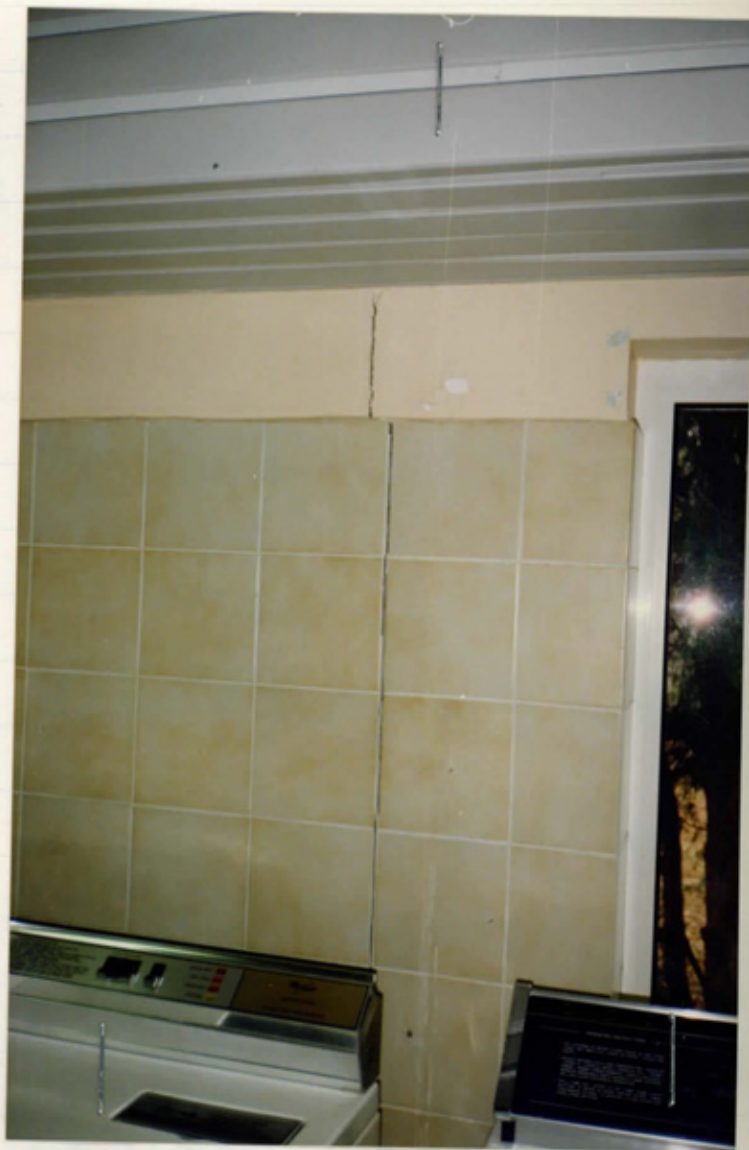
Photo #5
Laundry Room Interior
Side Wall Crack

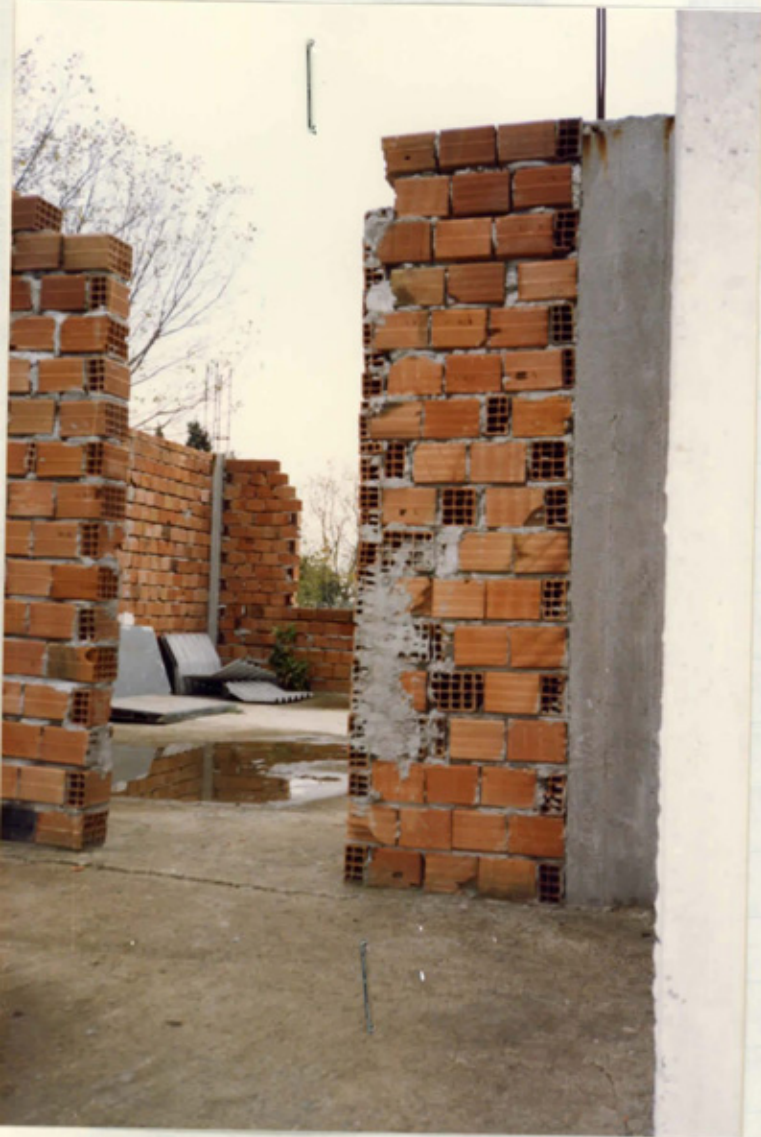
Photo #6

Sample of Turkish Style
Construction

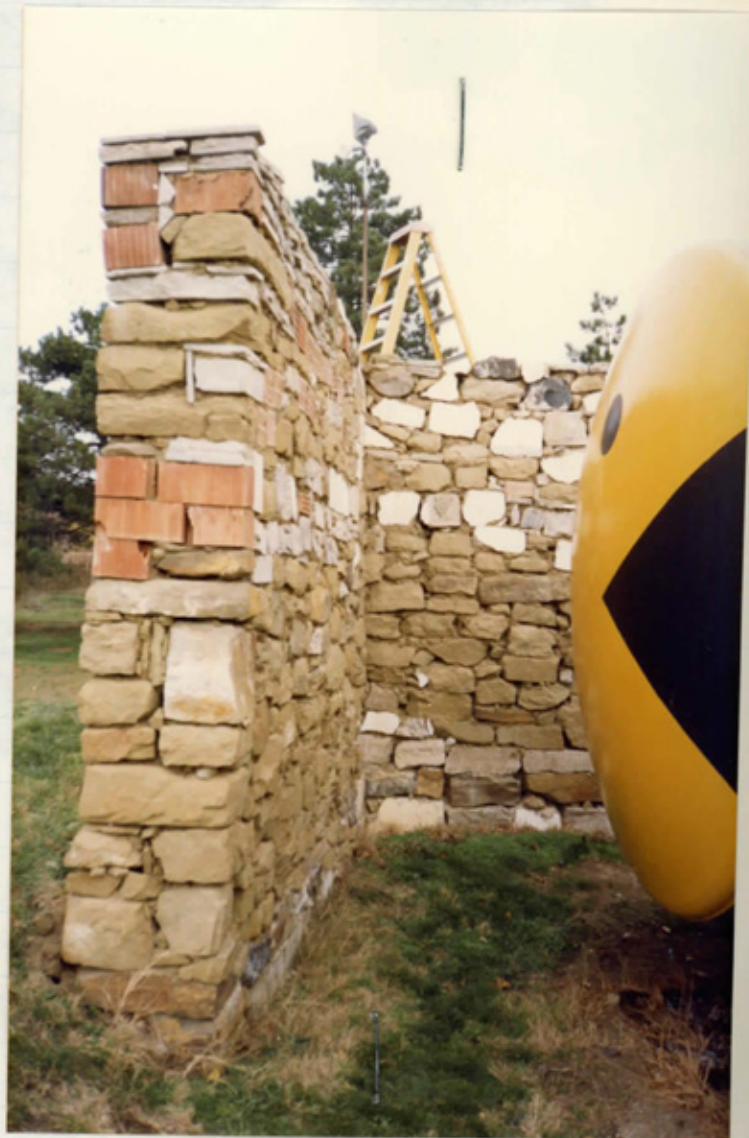
Photo #7

b. The Engineering Division will have to re-evaluate the need to remove the two foot thick and ten foot high rock wall acting as a firearms protection on the north side of the fuel tank enclosure (Photo 7). This wall would be very difficult for the station to remove then reinstall outside the fuel containment area. It may be just as easy for us to modify our contract to install the flexible containment liner around the wall. The volume capacity of the enclosed pool will have to check to see if there will be a problem.

Fuel Tank Protective Wall

Mod to
contract
pools.
D. J. M.

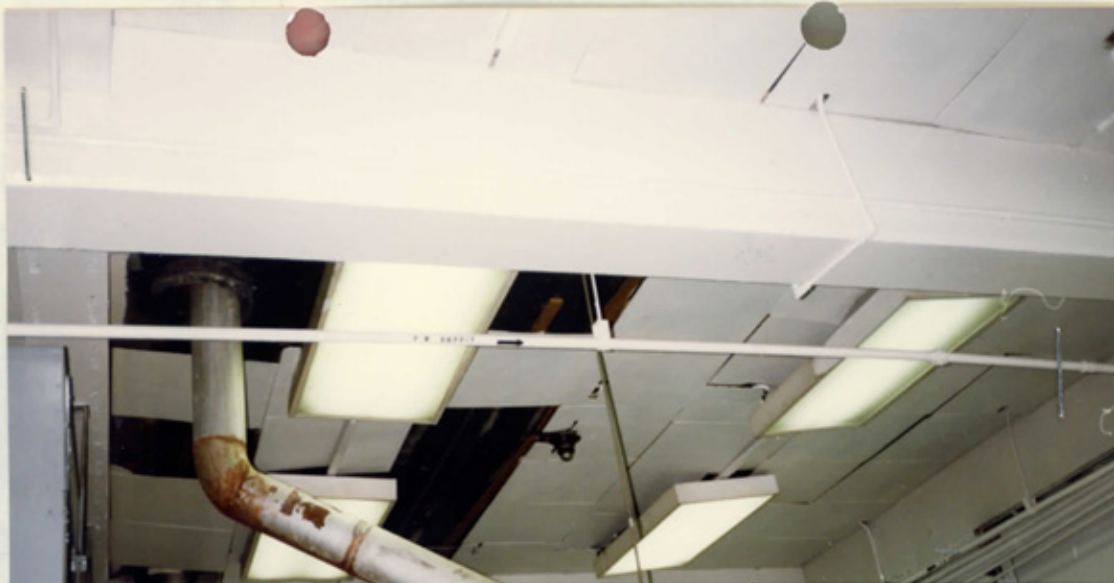
Photo #8
Generator Rm
Ceiling
Tiles

7. MKC Perron also showed me how asbestos (not friable) ceiling tiles are breaking free of the generator room ceiling (photos 8 thru 10). These tiles are not flaking asbestos and pose no health risk to station personnel. They should be replaced though and can easily be done by the station with funding from ACTEUR E-Division. The tiles securing method should be changed from nails to screws.
