Re: Kargaburun Mast investigation

We have pleasure in offering to you our report on the collapsed LORAN C mast radiator at Kargaburun, Turkey.

STRUCTURE: 625' LORAN C Mast; Navigation Beacon.
Triangular 5' Face Mast (Tube Construction)
Messrs. Stainless Inc. PENNSYLVANIA USA

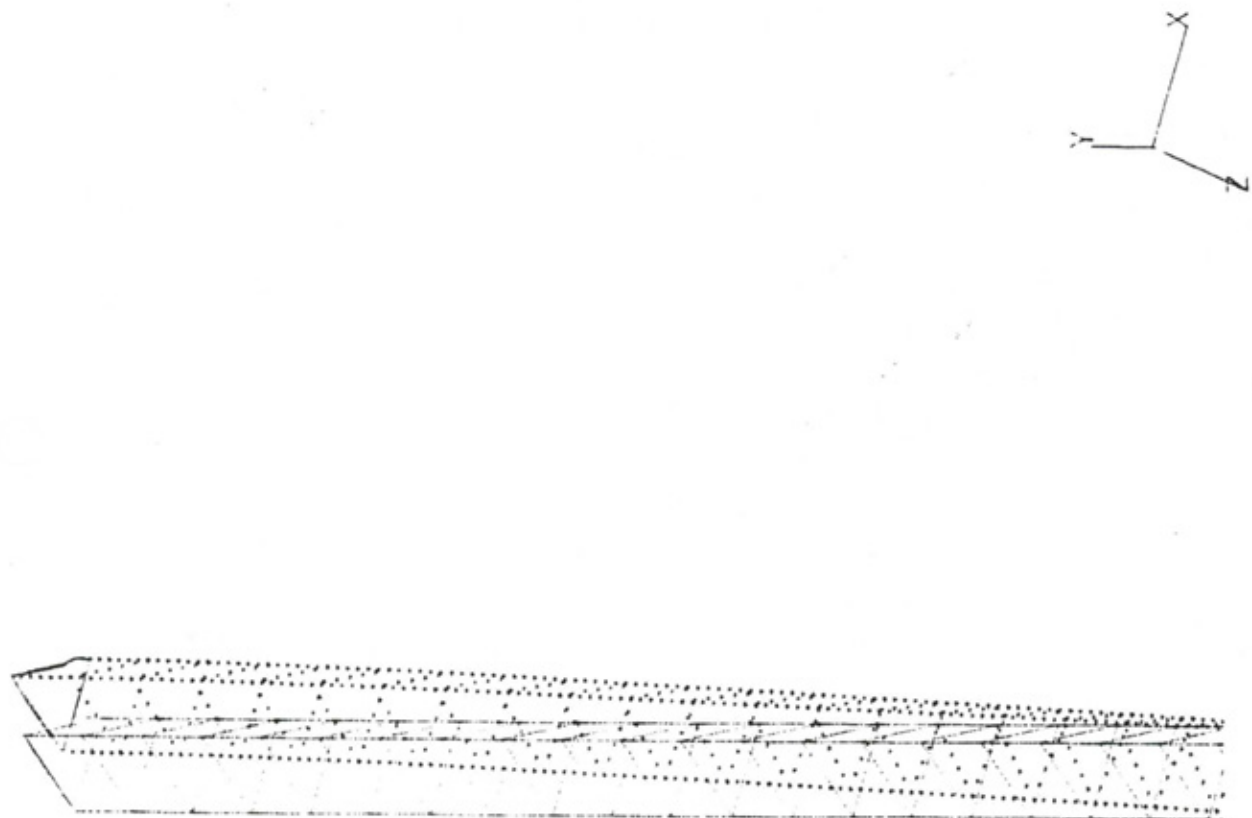
FIG. 2 - TOP DISPLACEMENTS @ INITIAL CONDITIONS

Analysis of the tower for initial pretensions under calm conditions shows that the tower was twisted and "out of plumb" prior to the collapse. The results of the analysis are summarised in table 1. The calculated vertical mast load at the base under initial conditions is 81,000 lbs.

Table 1 shows the effects of the unbalanced pretensions caused by the grade variations at the site. Table 1 reflects the equilibrium position of the mast under initial conditions with the guy and radial anchor point locations determined from the topographical information. Values in Table 1 refer to the model geometry. There is no direct correlation between the values in Table 1 and the reported twist and alignment data. Table 1 is based on an equilibrium position using a perfectly straight mast as datum. The alignment data is a set of averages for alignment and twist based on the positional placement of the measuring instrument. (Theoretically, the relative direction of twist and displacement should be the same as reported, if measured correctly).

The initial twist and deflection was caused by the uneven tensioning in the cables and the grade variation at the site. Although the tensions measured in the tower inspection report were within the manufacturers tolerances, the grade variation was not accounted for. Typically grade variations are accounted for during installation by moving the anchor block along the axis of the cable to maintain the same vertical angle. If the ground elevation at the work point of a particular guy is higher than the ground elevation at the tower base, the anchor is moved toward the tower. Conversely, if the guy anchor is than the tower base, the guy anchor is moved away from the tower.

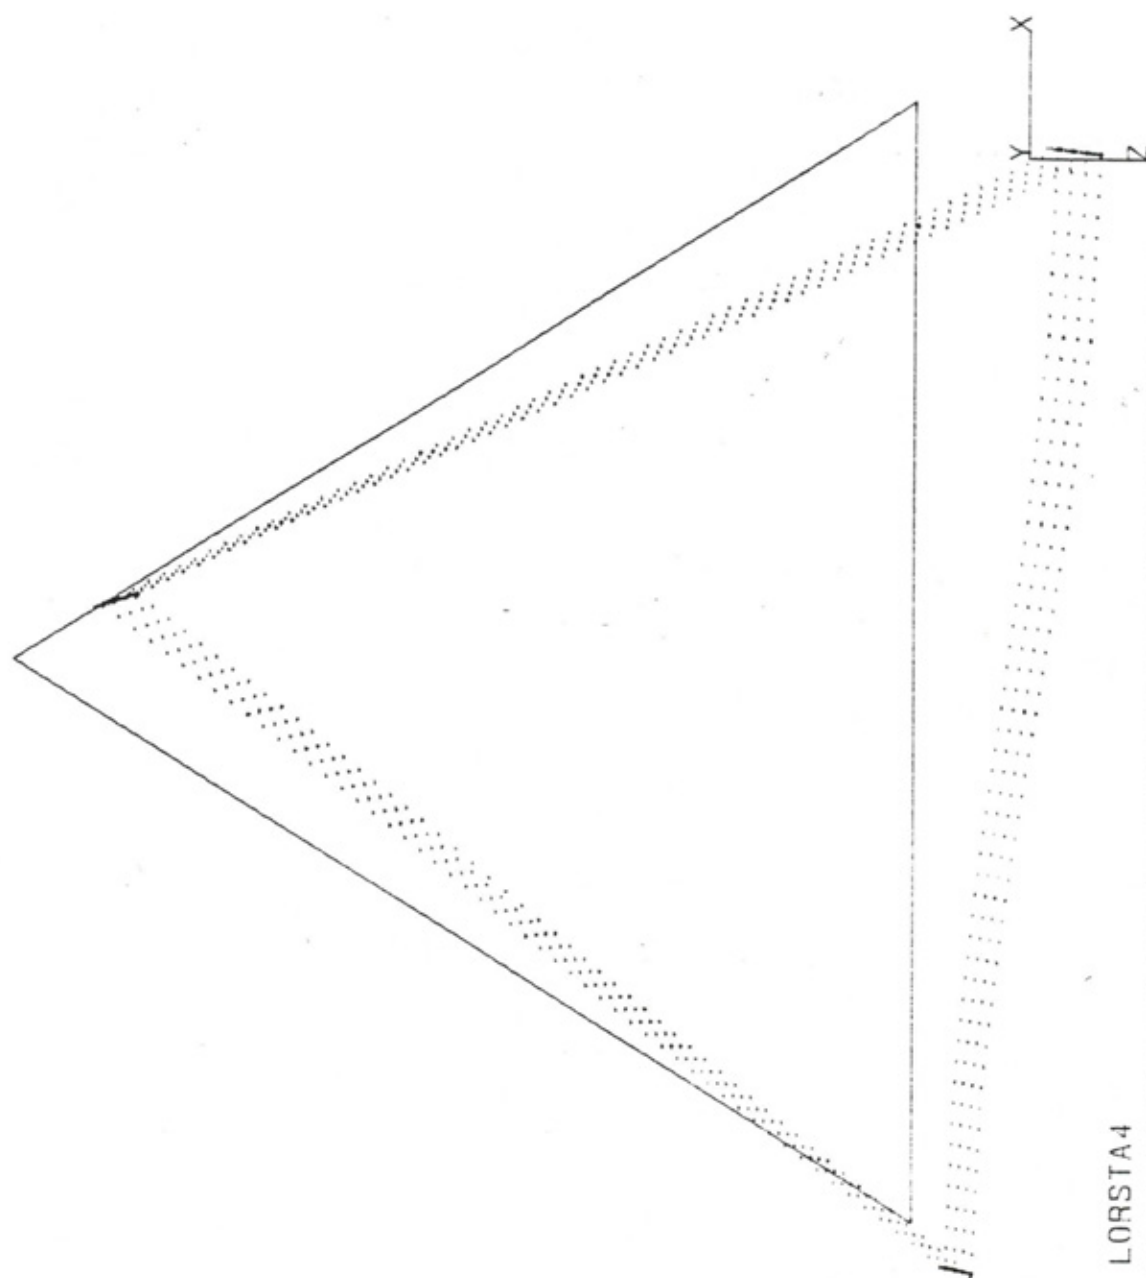
FIG. 3 - FAILURE MECHANISM @ SPAN 4

Fig 3 shows the failure mechanism at span 5.
 Fig 4 shows the displaced shape of the upper sections of the mast.

The results of the analysis of the mast under 1-1/2" snow load are summarised in Table 2. It is seen from Table 2 that the mast was severely torqued at level 4. Under normal wind loads, the LORSTA mast could tolerate the built in twist and "out of plumb" alignment caused by the grade variations and uneven tensions. However, the misalignment combined with the heavy snow loads caused the mast to buckle torsionally.

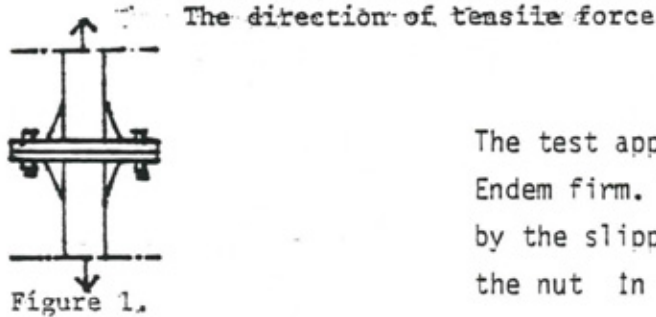
1.) Tensile test of bolts in gusset (the sample S8-S9)

The test apparatus was prepared by the Endem firm. The sample failed at 15 tons by the slipping of one of the bolts through the nut in figure 1.

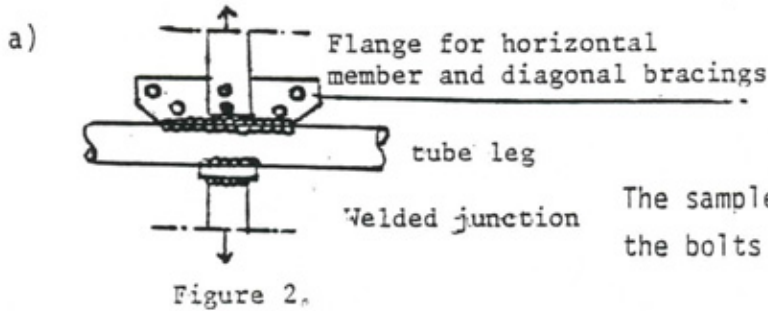
2) Test for shear of bolts in gusset (the sample S10-S11)

The sample failed at 10.8 tons by cutting the bolts in Figure 2.

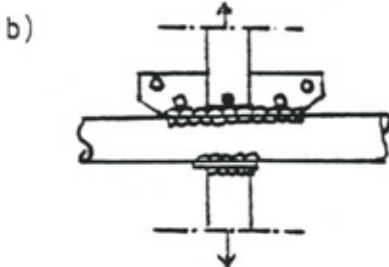
Tested two samples, failed at the same load at 5.8 tons by cutting the bolts in figure 3.

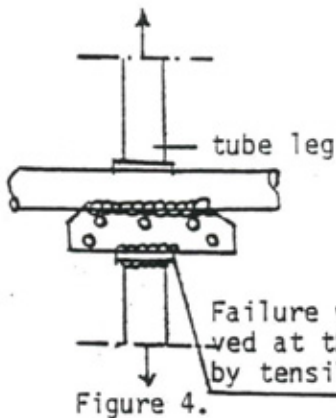
3) Tensile test of welded gusset plate (the sample S12-S13)

The Sample failed at 30.4 tons load at the intersection of the holding part and flange in figure 4.

Failure wasn't observed at the weld of the gusset.

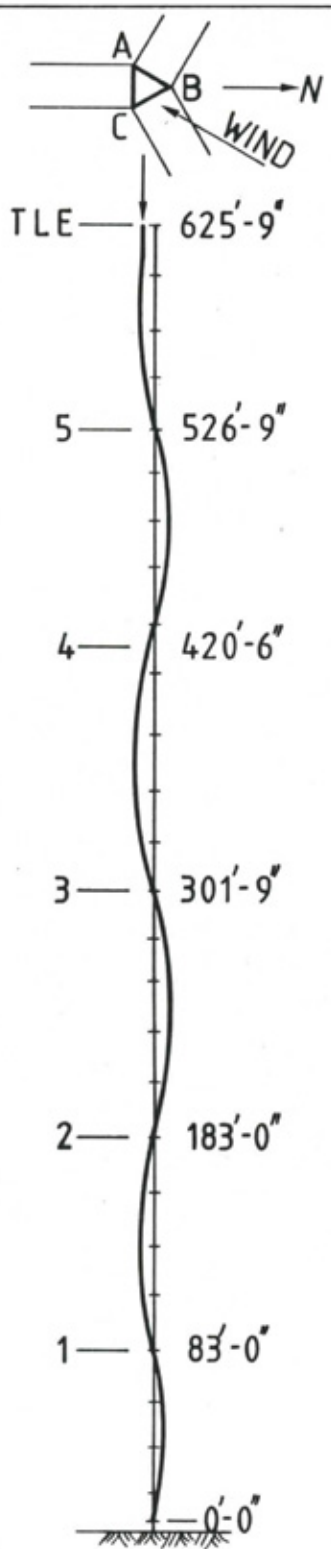
1st. Diagram
 Normal condition, subject
 to "as erected" geometry,
 under calm conditions.

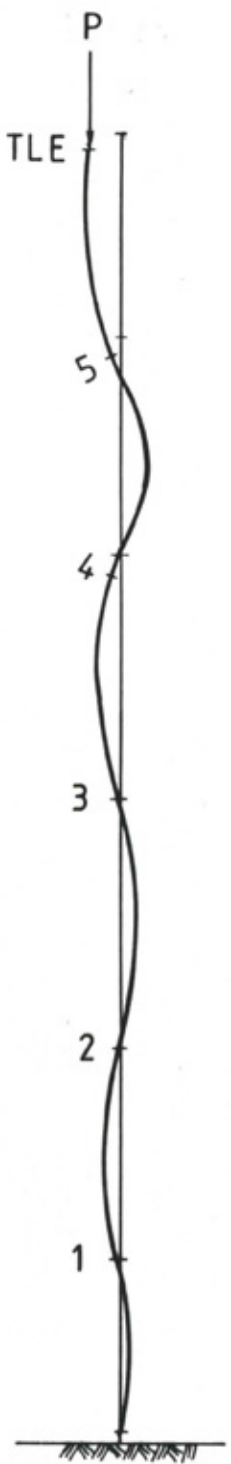
2nd. diagram

P. Critical reached (load approaching 215000 lbs.) including accretion of wet snow/ice tending to overload status, under light wind, with full stay & TLE compressions & self weight.

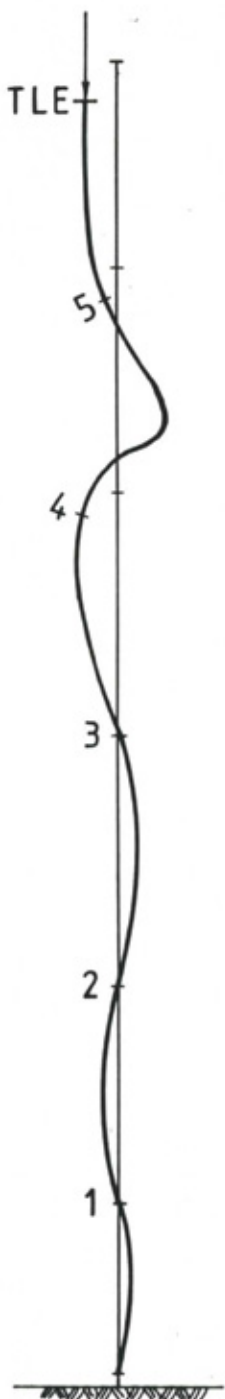
Buckling instability occurs, possibly in two zones concurrently forming mechanisms between mast sections 19&20 + between 14&15. This motion is believed to have been torsional clockwise causing tension failure in Leg B (19-20) & Leg C (14-15).

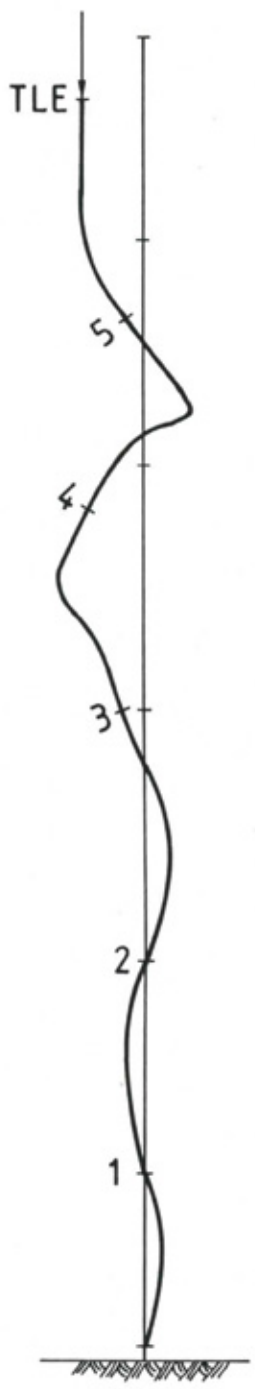
4th. Diagram

The down-thrust of 24 TLE's, 12 stays & excess "super-load" further accelerate the impending destruction.

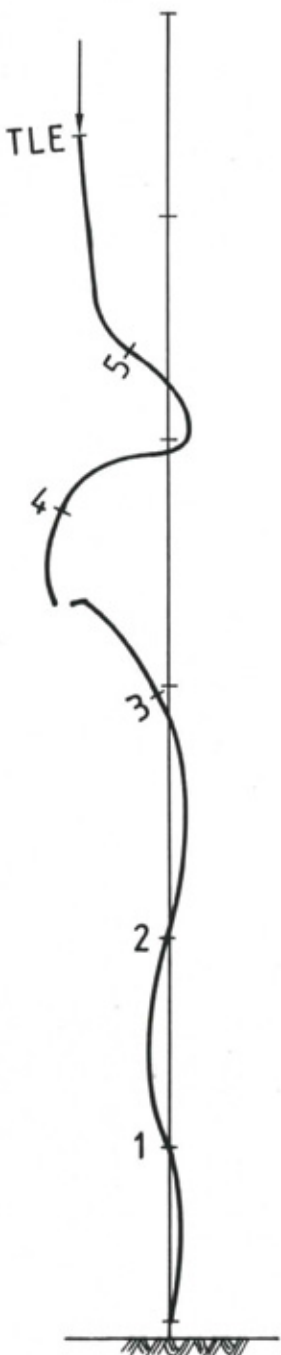
5th. Diagram

Legs A & B fail & part due to bending at the node formed between mast sections 14 & 15.

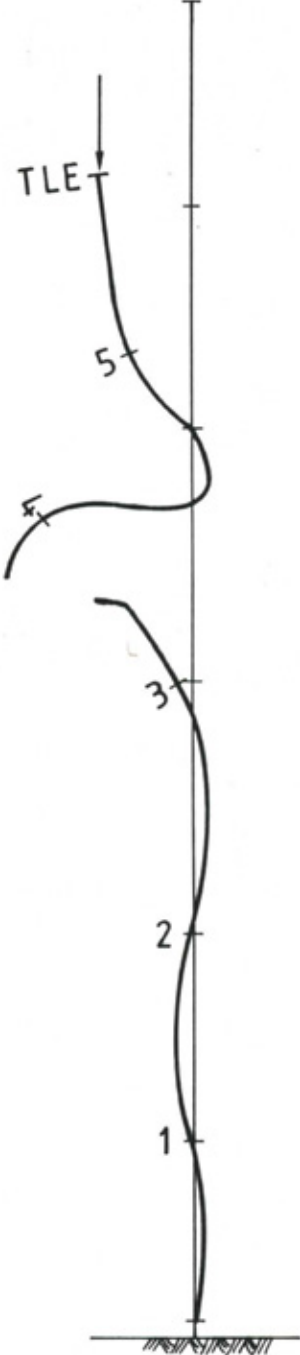
6th. Diagram

The release of energy in the failure tends to close the zone between stay levels 4 & 5 whilst down-ward movement continues.

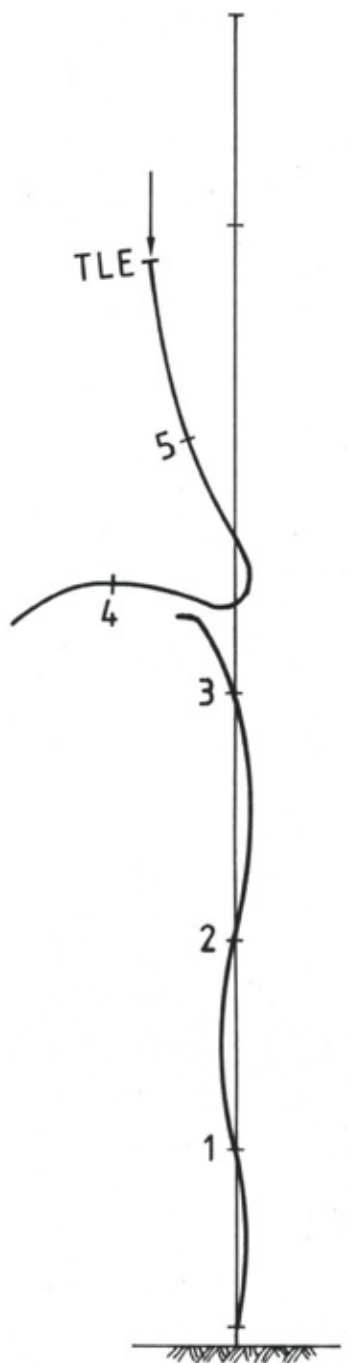
7th. Diagram

Possible collision between lower section & falling unit further closes the zone & imparts a rotation to the descending upper section.

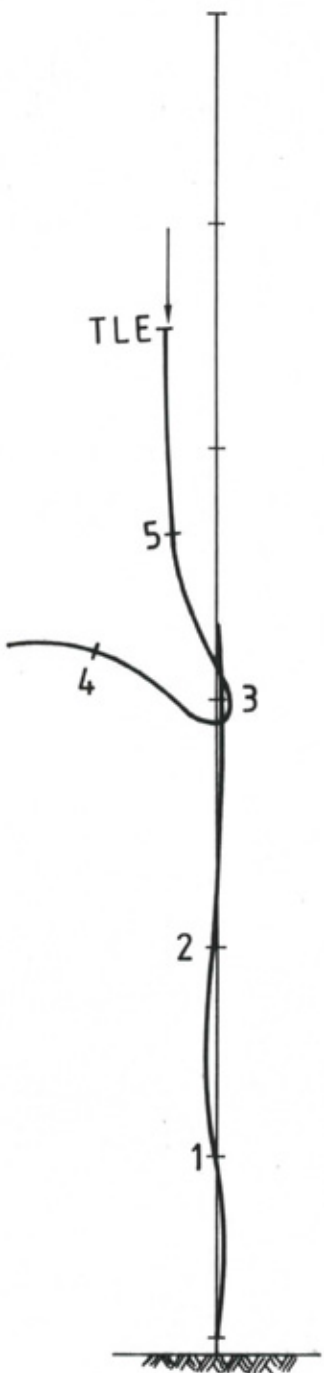
8th. Diagram

Broken section collides with & severs Level 3
Lane 3 stays.

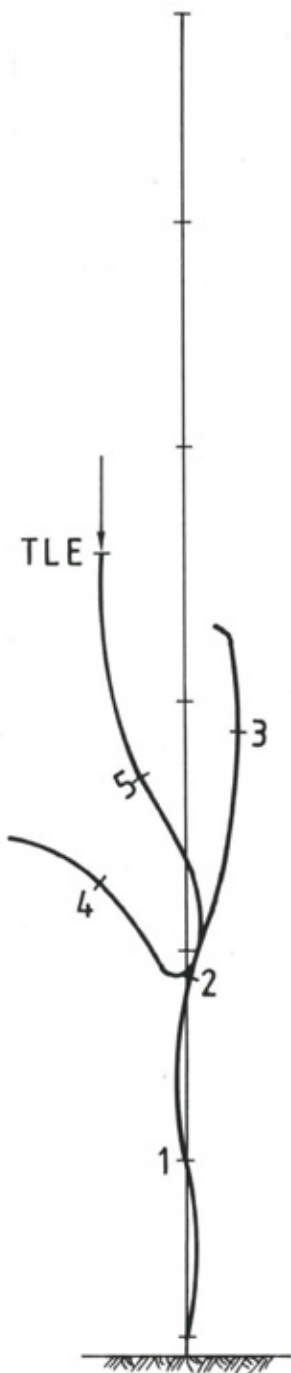
9th. Diagram

The lower section of the mast is now unstable at level 3 & starts to rotate & move in a S.E. direction. The shearing of Level 2 Lane 3 stays further amplifies this mode.

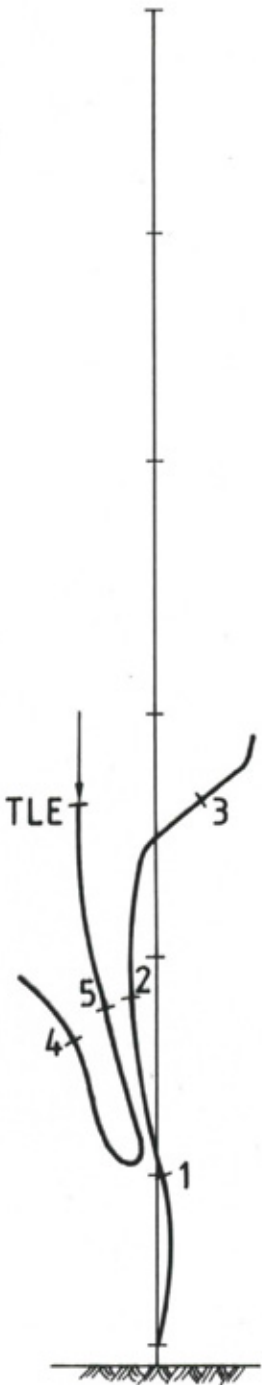
10th. Diagram

The falling section is severely twisted at the node zone & is further disrupted by severing the south stay at Level 1 Lane 3, causing fatal instability to the lower section of mast body.

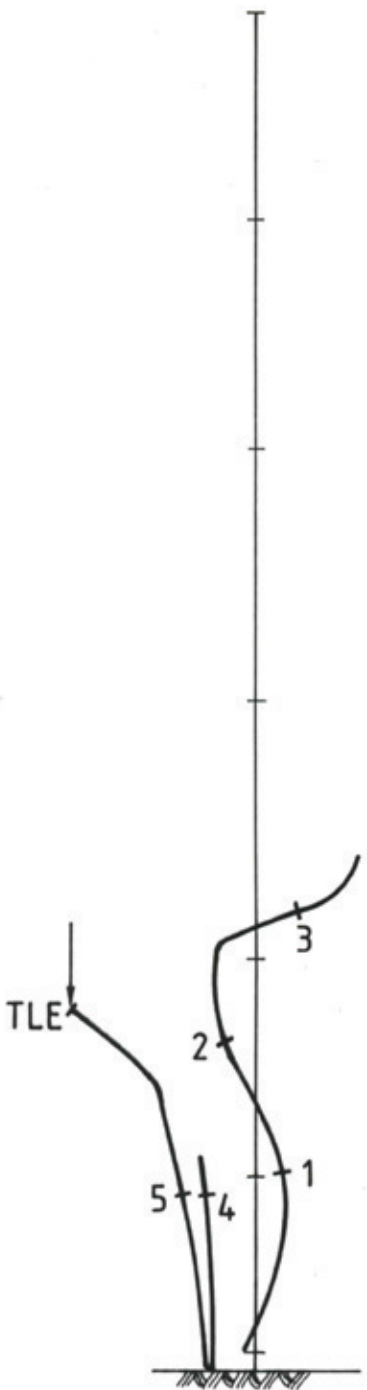
11th. Diagram

Before entering the ground South of the mast base, the descending section breaks stays Level 1 Lane 2 causing a change in direction of movement below Level 1 such that the mechanisms formed between mast sections 3&4 & between 11&12 are accentuated.

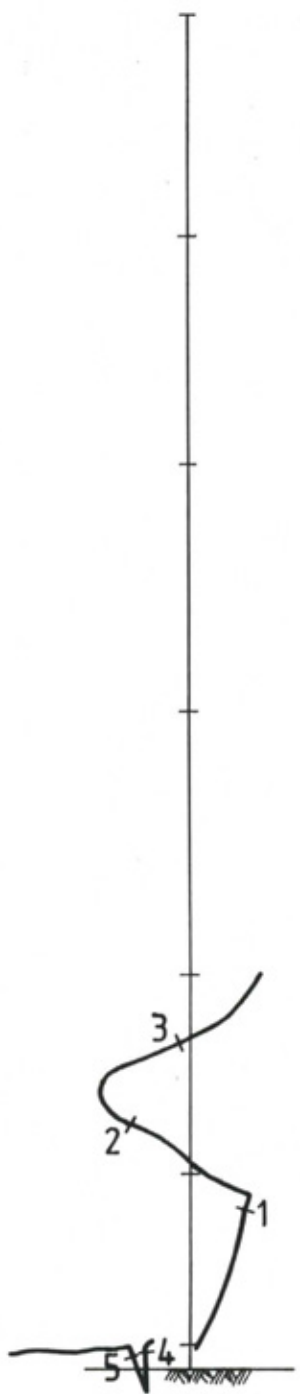
12th. Diagram

The upper section has impacted with great force & now the two limbs keel over in their respective directions. The mast section 23 is folded by virtue of the fact that most of the TLE's are still unbroken. Some "LAPP" insulators fail on impact. Mechanisms are now pronounced & base insulator is near to or has failed in shear.

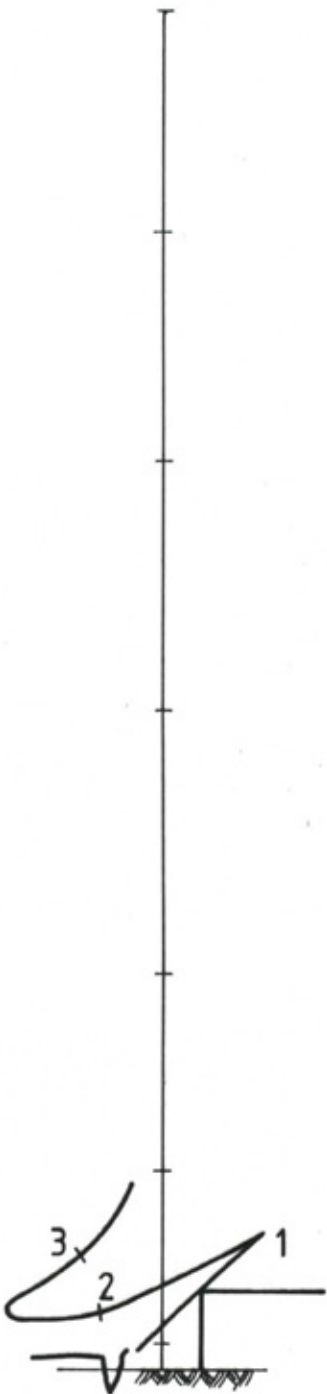
13th. Diagram

All stability is removed
& mast sections 1-3
contact Auxiliary
building.
