## Generator Engine Casualty and Replacement at an Arctic Loran Station

*LTJG W. H. Wilson, Jr., USCG  
Commanding Officer*

*Cape Atholl Loran Transmitting Station  
Greenland*

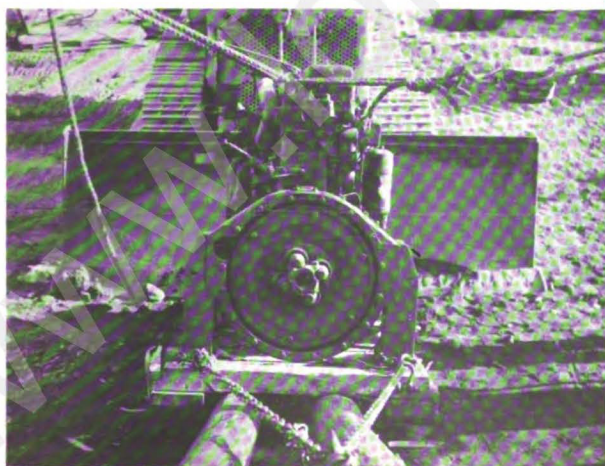
On the outside, both the D-7 and the D-8 Caterpillar tractors jockeyed the engine into position at the bottom of the ramp, Figure 2. The engineroom chain hoist was run out and connected to a chain bridle which was attached to the engine mounts where the mounts were attached to the packing crate bottom. At this time the two preventers were attached to the lifting rings on top of the engine and personnel were positioned to tend them. Before any further action was taken, one man was designated in charge of the scene outside and one designated in charge inside the engineroom. Adequate safety observers were posted strategically.

Figure 2. Engine placed in position at bottom of ramp.

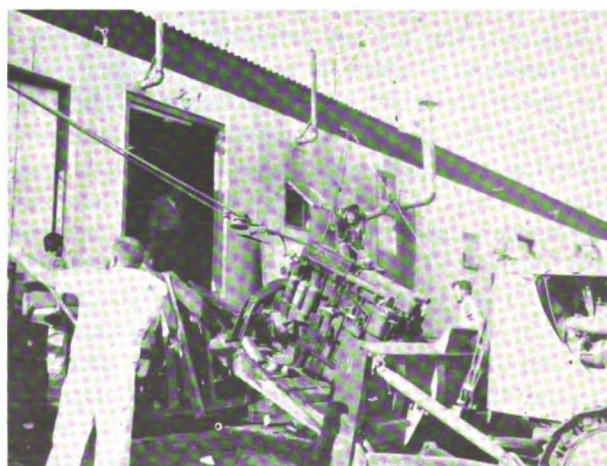
On the given signal, the D-8 tractor commenced pushing the 5135-pound engine up the ramp while the engineroom personnel took in on the chain hoist, Figure 3. All preventers were kept taut to prevent the engine from falling off of the narrow ramp. The lack of heavy timbers prevented the building of a solid full-width ramp.

Figure 3. The engine being hoisted up ramp with steadying lines.

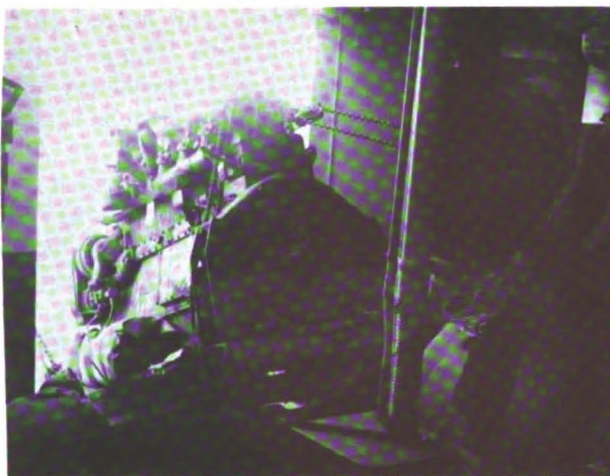
Figure 4. Engine at entrance into building.

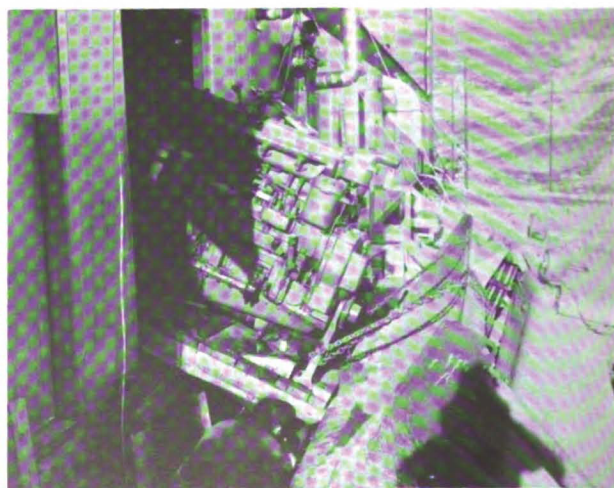
further without crushing the main ramp timbers or dislodging them. Additional holding chains were put on the engine and the bulldozer backed clear for a better position. It was noticed at this time that the angle of entry into the engine room was excessively steep and to push the engine further would only cause it to slam to the deck once the point of balance was passed, Figure 4. To prevent personnel injury and structural damage, a 4- by 4-inch cribbing was laid out on the deck in the engine-room, and two hydraulic jacks were placed inside the cribbing and below the engine bed. The bulldozer was then driven up to the engine and the engine was secured, by chains, to the bulldozer blade while in a lowered position, Figure 5. Continuing the push from the outside, the engine passed its point of balance and dropped about one inch, being caught by the preventer chains on the bulldozer blade. At this point, the pre-set cribbing was raised by the addition of more 4- by 4-inch timbers and the jacks were set under pressure under the inside of the skids. By raising the blade and lowering the jacks simultaneously, it was possible to tilt the engine downward into the engineroom until the bulldozer blade became two-blocked. The engine was still precariously balanced so a quick modification was added. A chain hoist was connected, as a downhaul, to the bed of the No. 1 generator engine which is located directly in front of the knockout partition and five feet away from it. When all slack was removed from the downhaul, the chains were removed from the bulldozer blade and

Figure 5. Engine in building entrance. Note lifting chains on dozer blade.
