Re: Kargaburun Mast investigation

We have pleasure in offering to you our report on the collapsed LORAN C mast radiator at Kargaburun, Turkey.

STRUCTURE: 625' LORAN C Mast; Navigation Beacon.
Triangular 5' Face Mast (Tube Construction)
Messrs. Stainless Inc. PENNSYLVANIA USA

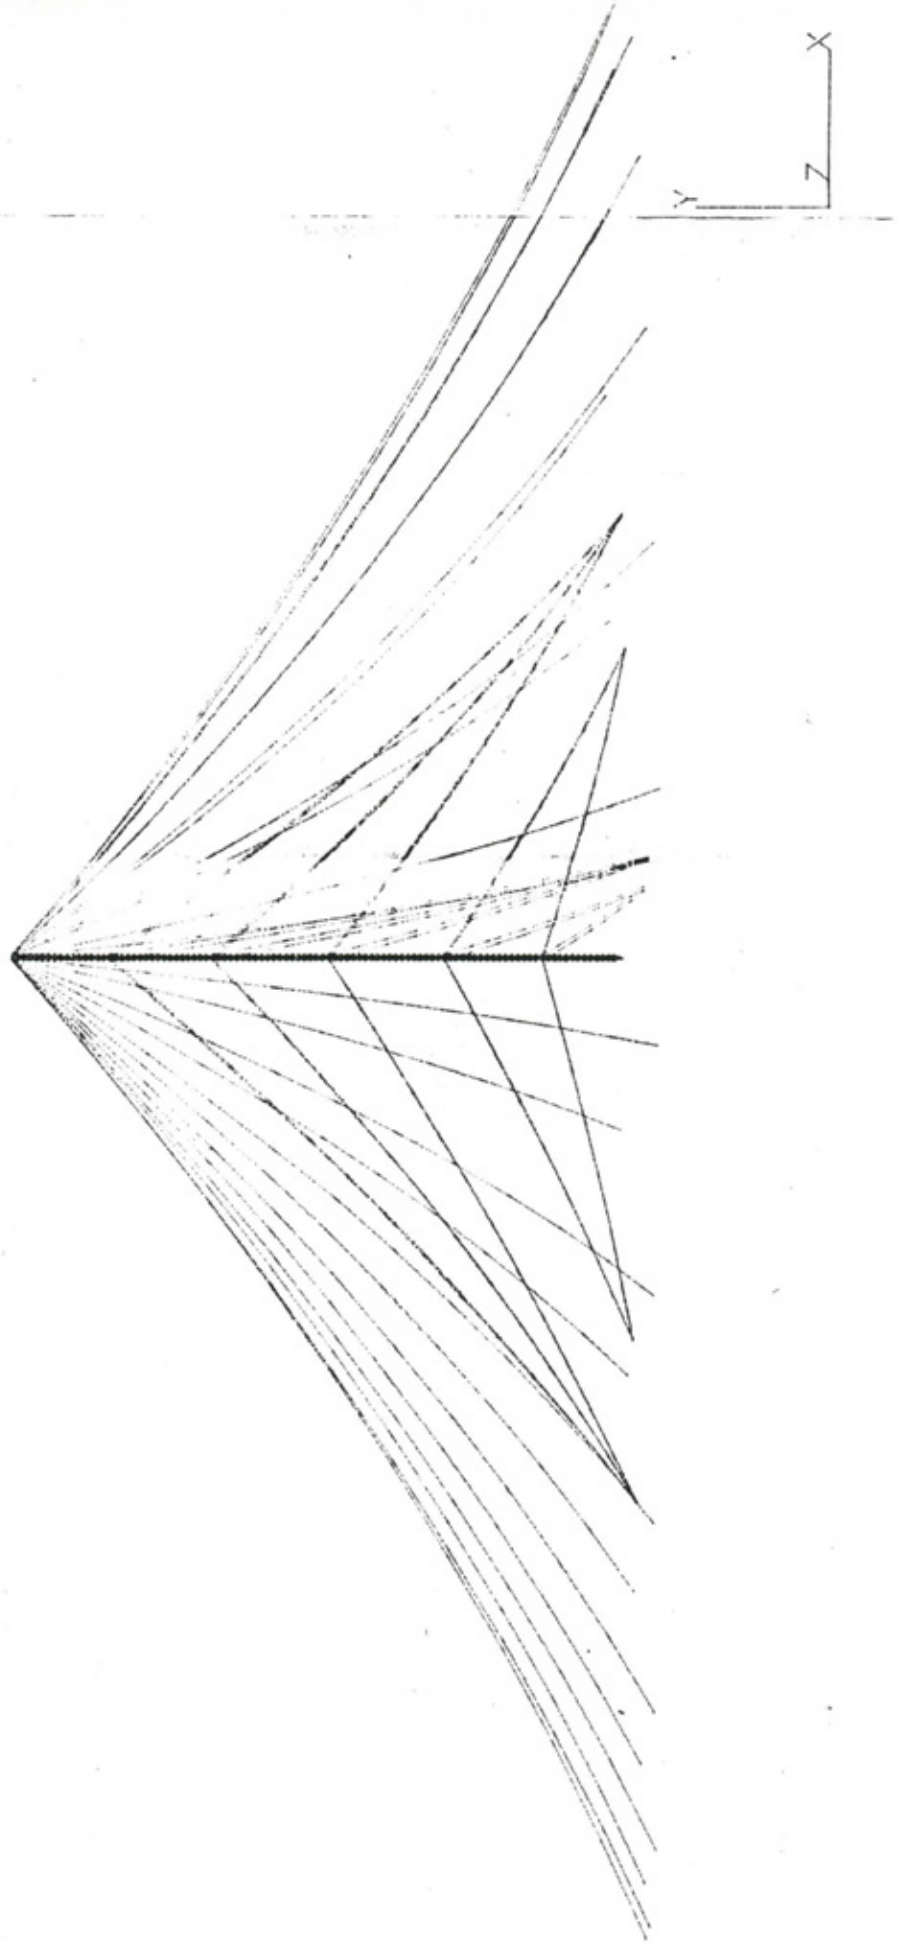
FIG. 1 - 625 FT LORAN "C" MAST KARGABURAN, TURKEY

Fig 1 shows the 625ft LORSTA mast under initial pretensions. The tower is a Stainless Type G5, modified to accept the top radials by replacing the standard horizontal girts at the top of the tower with the radial umbrella support beam. The tower model geometry is based on the original Stainless installation drawings covered under report #1100. Material properties for the EHS guys and ACSR radiators were obtained from standard handbooks on these materials. Tower material properties were obtained from the manufacturer and reflect the yield strengths from the physical and chemical reports from the producers.

Final tensioning of the mast should result in a vertically aligned mast under calm conditions. Mast guys and radials should be tensioned to the pretensions specified on the manufacturer's drawings, adjusted for grade variation and temperature effects. If the existing anchors are to be used for the new mast, grades should be verified and the proper tension adjustments calculated. Tensioning shall be applied incrementally at each guy level, in order to keep the mast nearly vertical during (construction) tensioning.

It should also be noted that the existing foundations may well be inadequate to sustain the TACO mast, bearing in mind that the overall weight on the base foundation will be much higher than for the Stainless mast and that the guy tensions are also much higher than those for the Stainless mast.
