Time Line-Synopsis of Loran Exposure History

by ETCM Charles Severance (USCG, ret.) 2007

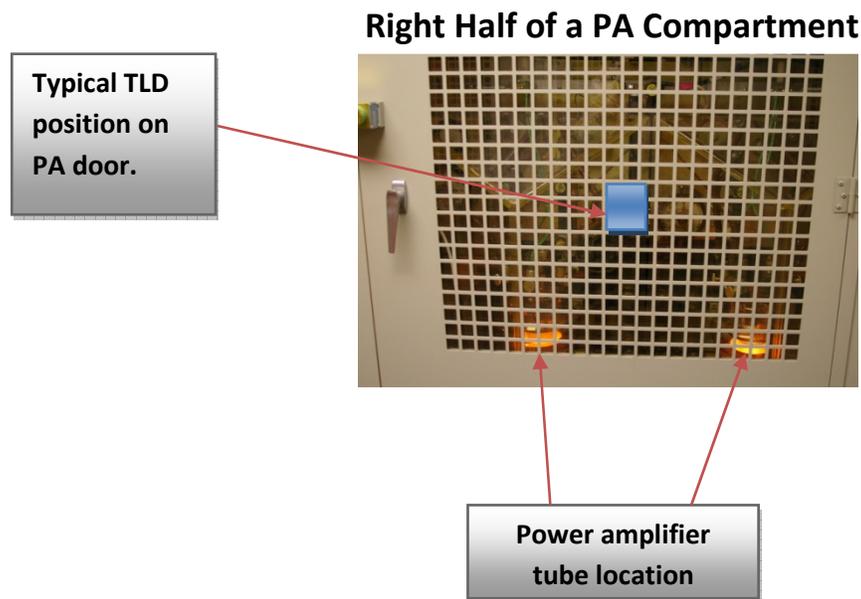
- TLD positioned on outside of each PA tube cabinet avoiding obstruction by the metal grate which makes up the cabinet. The TLD's were centered on the outside of the glass door, and not aligned with the PA tubes or Drivers. The TLD's were above and between the tubes facing into the transmitter.

- Testing of the second transmitter was done in the same fashion as the first, when the second transmitter was on air.
- Two sets of TLDs were kept away from the radiation as controls.
- TLDs were kept on each transmitter for seven days.
- Sketches of TLD placement, and transmitter spaces were made by the Loran crew for use by USPHS (FDA).
- All TLDs were returned to USPHS (FDA) in Rockville, MD when completed.

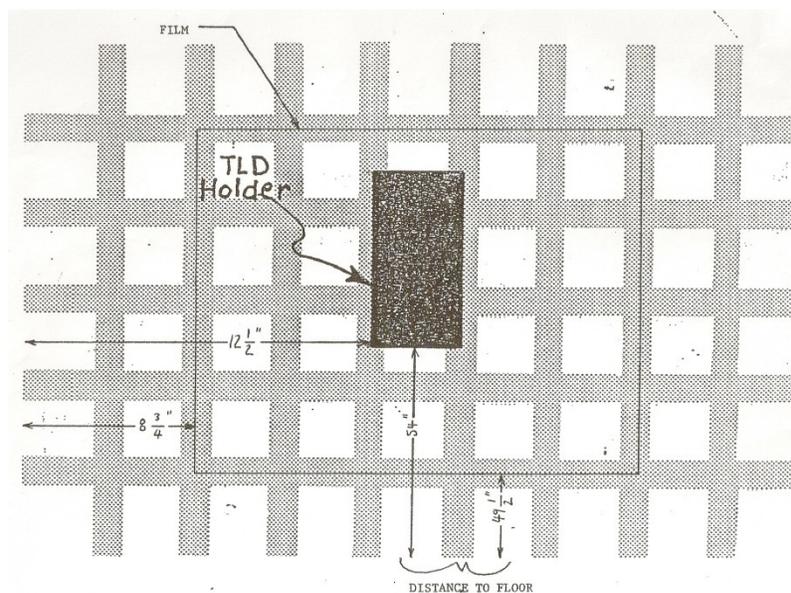
- Multiple Loran rates could significantly affect (increase) radiation exposure.
- Difference in the number of PA sections, and driver sections could affect (increase) radiation exposure.
- TLD's and film could not be positioned as directed because TLD's and film are much larger than the space in the PA window grate. Metal grating blocked portions of the TLD's.

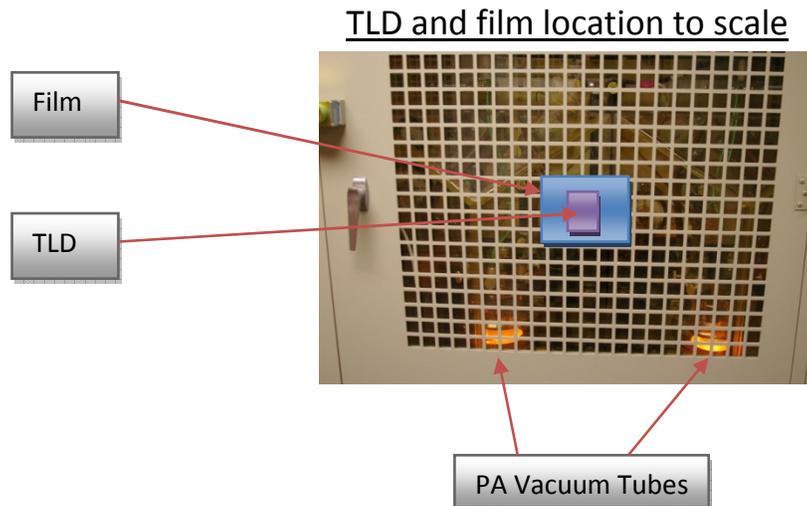
- Dosimeters should have been placed in front of each PA tube, at tube level. TLDs and film were installed above and between the PA tubes and not directed at the PA tubes.

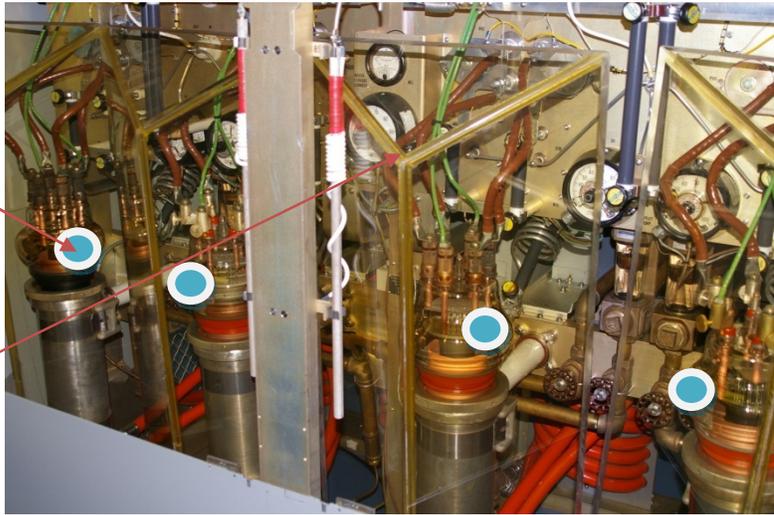
Lead Acrylic Shielding

Dosimeter locations on tube envelopes behind lead acrylic shielding.

- Since the Victoreen 440 is directional the total exposure from the lineup of the tubes along the hallway may be higher than the readings reported.
- Lead impregnated acrylic shielding was tested and found to be effective in shielding X-rays.
- A personal dosimeter program established in September 1993 resulted in personal exposures of **5.7 mR/hr** and **5.9 mR/hr** for two of three monitored personnel.
- Concerns of radiation exposure by station personnel were explained as not likely since limits are based not on harm to the individual, but on the maximum amount of exposure that could be accepted by the cumulative gene pool.
- Concerns of radiation exposures on pregnant women were deferred to USPHS (FDA) office in Rockville, MD.

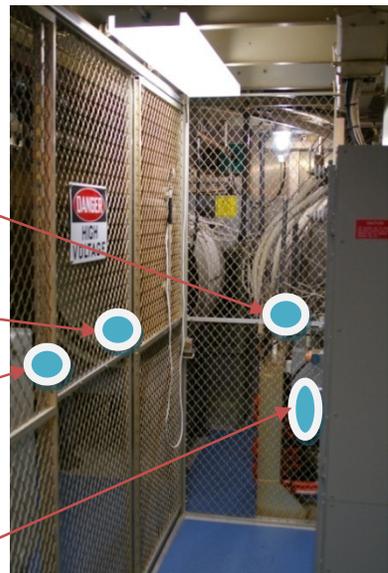
Approximate Dosimeter Locations

- Hazardous Leakage radiation in the access area behind the 1A4 Section cabinet was detected by dosimeters placed on the accessible part of the fence, and 1A4 cabinet door where technicians normally stand when looking for transmitter arcing.

Transmitter One **5.4 mR/hr**
 Transmitter Two **6.4 mR/hr**

Transmitter One **0.40 mR/hr**
 Transmitter Two **0.22 mR/hr**

Located on 1A4 Cabinet Door
 Transmitter One **1.5 mR/hr**
 Transmitter Two **0.0 mR/hr**
